Task Force SAFE

Inspection-Report_TFSAFE_Full_KFAB22_Oiltown-Combat-COMMS_116_05-06-26_1-7

Base Location	KFAB (Jordan)	Date:	05-JUN-2026
Base Code	KFAB22	Team #:	116
Building #	Oiltown-Combat-COMMS	System Voltage	230/400
Building Type	OFFICE	Inspection Phase	Full Inspection
Previous Report #:	N/A	Work Order:	TFS-KFAB22-2026-00005

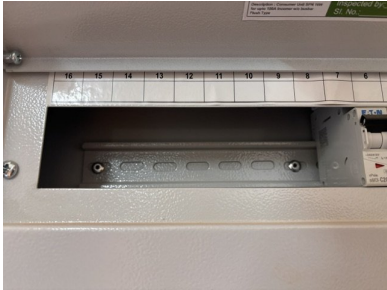
Deficiency #1	RAC 2	Occurrences: 10
----------------------	--------------	------------------------

Description: Breaker blanks missing from dead front.

Location:	At CDP.
Category:	Improper Use / Damaged
Equipment:	CDP
Imminent:	No
Action:	N/A
Assigned To:	O&M; Provider
Code:	British Standard 132: Protection against electric shock
Status:	Open

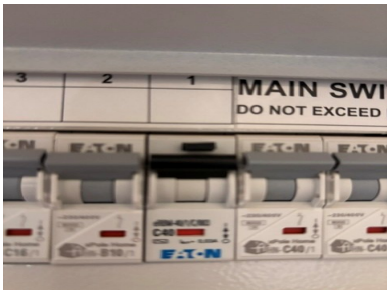
Deficiency #2	RAC 2	Occurrences: 1
----------------------	--------------	-----------------------

Description: Type AC RCD used. Type AC RCD is not suitable for this building.

Location:	Within the CDP.
Category:	Improper Use / Damaged
Equipment:	CDP
Imminent:	No
Action:	N/A
Assigned To:	O&M; Provider
Code:	British Standard 132: Protection against electric shock
Status:	Open

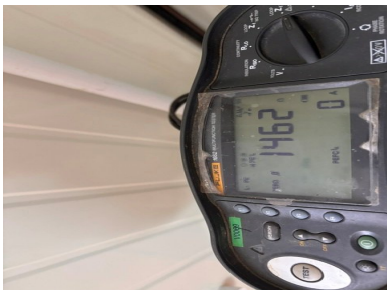
Deficiency #3	RAC 2	Occurrences: 6
----------------------	--------------	-----------------------

Description: High Zs reading of 1462 ohms throughout the office.

Location:	All circuits.
Category:	Grounding and Bonding
Equipment:	CDP
Imminent:	No
Action:	N/A
Assigned To:	O&M; Provider
Code:	British Standard 542: Earthing arrangements
Status:	Open

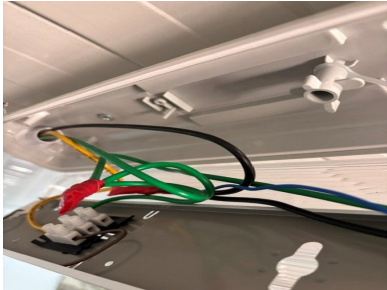
Deficiency #4	RAC 2	Occurrences: 9
----------------------	--------------	-----------------------

Description: Twist taped connections on live, neutral, and CPC.

Location:	Within internal light fixtures.
Category:	Improper Terminations
Equipment:	WLT
Imminent:	No
Action:	N/A
Assigned To:	O&M; Provider
Code:	British Standard 526: Electrical connections
Status:	Open

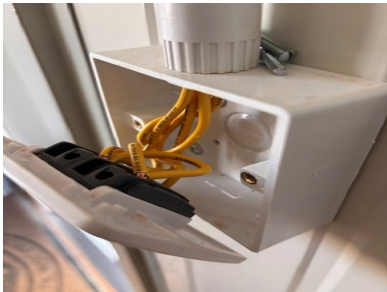
Deficiency #5	RAC 2	Occurrences: 2
----------------------	--------------	-----------------------

Description: No CPC at light switches.

Location:	At light switches.
Category:	Grounding and Bonding
Equipment:	WLT
Imminent:	No
Action:	N/A
Assigned To:	O&M; Provider
Code:	British Standard 542: Earthing arrangements
Status:	Open

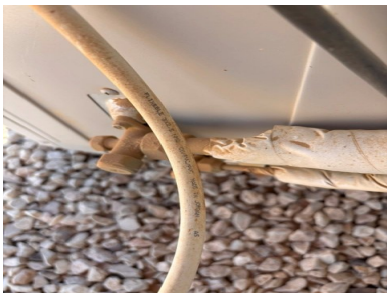
Deficiency #6	RAC 2	Occurrences: 2
----------------------	--------------	-----------------------

Description: Unlisted cables.

Location:	At external AC condensers.
Category:	Unlisted Equipment
Equipment:	WLT
Imminent:	No
Action:	N/A
Assigned To:	O&M; Provider
Code:	British Standard 511: Compliance with standards
Status:	Open

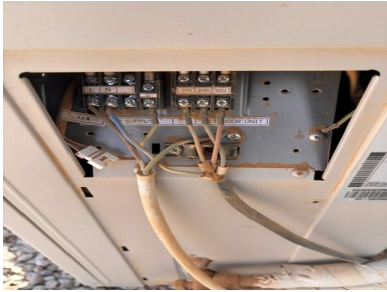
Deficiency #7	RAC 2	Occurrences: 2
----------------------	--------------	-----------------------

Description: Cable clips not used: strain on terminations.

Location:	At external AC condensers.
Category:	Improper Use / Damaged
Equipment:	WLT
Imminent:	No
Action:	N/A
Assigned To:	O&M; Provider
Code:	British Standard 522: Selection and erection of wiring systems in relation to external influences
Status:	Open
