## Task Force SAFE

## Inspection-Report\_TFSAFE\_Full\_ALQ26\_SDP-1-1-N\_113\_06-06-26\_1-3

<b>Base Location</b>	Al Quwayrah	<b>Date:</b>	06-JUN-2026
<b>Base Code</b>	ALQ26	<b>Team #:</b>	113
<b>Building #</b>	SDP-1-1-N	<b>System Voltage</b>	230/400
<b>Building Type</b>	SDP	<b>Inspection Phase</b>	Full Inspection
<b>Previous Report #:</b>	N/A	<b>Work Order:</b>	TFS-ALQ26-2026-00005

SDP-1-1-N is located on the north perimeter behind the reefer units.

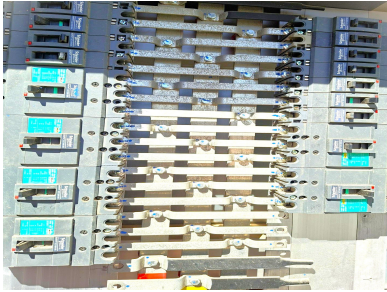
<b>Deficiency #1</b>	<b>RAC 2</b>	<b>Occurrences: 1</b>
----------------------	--------------	-----------------------

**Description:** SDP missing deadfront. Deadfront was located and installed.

<b>Location:</b>	Within SDP.
<b>Category:</b>	Improper Use / Damaged
<b>Equipment:</b>	SDP
<b>Imminent:</b>	No
<b>Action:</b>	N/A
<b>Assigned To:</b>	Task Force SAFE
<b>Code:</b>	British Standard 132: Protection against electric shock
<b>Status:</b>	Closed / Repaired

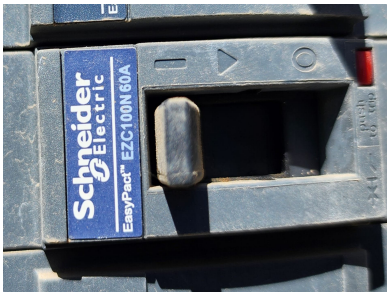
<b>Deficiency #2</b>	<b>RAC 2</b>	<b>Occurrences: 1</b>
----------------------	--------------	-----------------------

**Description:** Oversized. 10mm<sup>2</sup> conductors fed from 60A 1P MCCB.

<b>Location:</b>	Within SDP.
<b>Category:</b>	Improper Use / Damaged
<b>Equipment:</b>	SDP
<b>Imminent:</b>	No
<b>Action:</b>	N/A
<b>Assigned To:</b>	O&M; Provider
<b>Code:</b>	British Standard Appx 4: Current carrying capacities and voltage drop for cables
<b>Status:</b>	Open

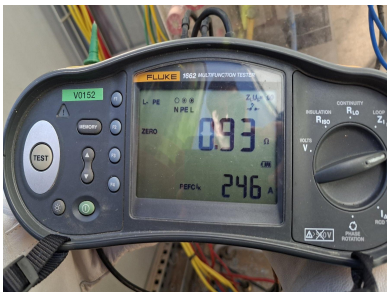
<b>Deficiency #3</b>	<b>RAC 2</b>	<b>Occurrences: 1</b>
----------------------	--------------	-----------------------

**Description:** Ze reading of 0.93 Ohms exceeds the maximum permitted tolerance of 0.8 Ohms.

<b>Location:</b>	Within SDP.
<b>Category:</b>	Grounding and Bonding
<b>Equipment:</b>	SDP
<b>Imminent:</b>	No
<b>Action:</b>	N/A
<b>Assigned To:</b>	O&M; Provider
<b>Code:</b>	British Standard 132: Protection against electric shock
<b>Status:</b>	Open
