Task Force SAFE

Inspection-Report_TFSAFE_Full_KFAB22_Oiltown-NIPR_116_06-06-26_1-6

Base Location	KFAB (Jordan)	Date:	06-JUN-2026
Base Code	KFAB22	Team #:	116
Building #	Oiltown-NIPR	System Voltage	230/400
Building Type	OFFICE	Inspection Phase	Full Inspection
Previous Report #:	N/A	Work Order:	TFS-KFAB22-2026-00006

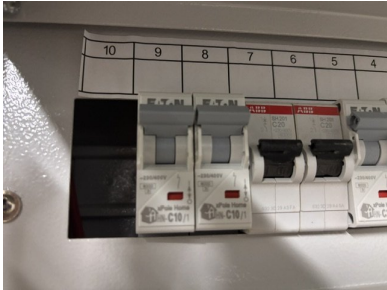
Deficiency #1	RAC 2	Occurrences: 1
----------------------	--------------	-----------------------

Description: Breaker blank missing from dead front.

Location:	At CDP.
Category:	Improper Use / Damaged
Equipment:	CDP
Imminent:	No
Action:	N/A
Assigned To:	O&M; Provider
Code:	British Standard 132: Protection against electric shock
Status:	Open

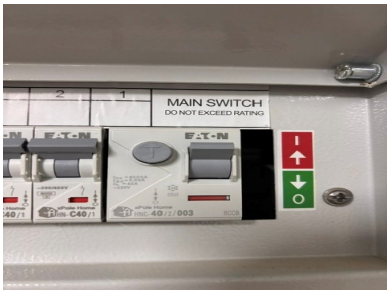
Deficiency #2	RAC 2	Occurrences: 1
----------------------	--------------	-----------------------

Description: Type AC RCD used. Type AC RCD is not suitable for this building.

Location:	Within the CDP.
Category:	Improper Use / Damaged
Equipment:	CDP
Imminent:	No
Action:	N/A
Assigned To:	O&M; Provider
Code:	British Standard 132: Protection against electric shock
Status:	Open

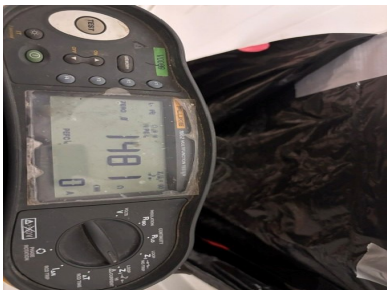
Deficiency #3	RAC 2	Occurrences: 6
----------------------	--------------	-----------------------

Description: High Zs reading of 1481 ohms throughout the office.

Location:	All circuits.
Category:	Grounding and Bonding
Equipment:	WLT
Imminent:	No
Action:	N/A
Assigned To:	O&M; Provider
Code:	British Standard 542: Earthing arrangements
Status:	Open

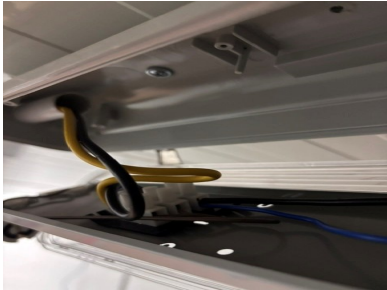
Deficiency #4	RAC 2	Occurrences: 1
----------------------	--------------	-----------------------

Description: No CPC to lighting circuit.

Location:	Within lighting circuit including switches.
Category:	Grounding and Bonding
Equipment:	LTG
Imminent:	No
Action:	N/A
Assigned To:	O&M; Provider
Code:	British Standard 542: Earthing arrangements
Status:	Open

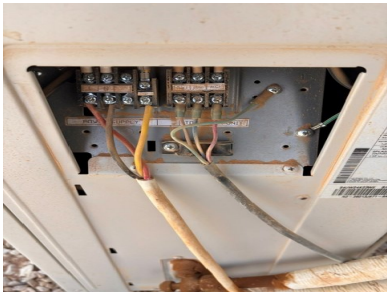
Deficiency #5	RAC 2	Occurrences: 2
----------------------	--------------	-----------------------

Description: Cable clips not used: strain on terminations.

Location:	At external AC condensers.
Category:	Improper Use / Damaged
Equipment:	WLT
Imminent:	No
Action:	N/A
Assigned To:	O&M; Provider
Code:	British Standard 522: Selection and erection of wiring systems in relation to external influences
Status:	Open

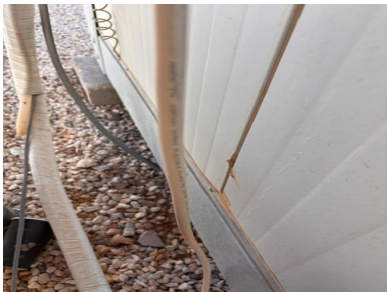
Deficiency #6	RAC 2	Occurrences: 2
----------------------	--------------	-----------------------

Description: Unlisted cables.

Location:	Within external AC condensers supply cables.
Category:	Unlisted Equipment
Equipment:	WLT
Imminent:	No
Action:	N/A
Assigned To:	O&M; Provider
Code:	British Standard 511: Compliance with standards
Status:	Open
