## Task Force SAFE

**Inspection-Report\_TFSAFE\_Full\_ALQ26\_SDP-1-2-E\_113\_08-06-26\_1-9**

<b>Base Location</b>	Al Quwayrah	<b>Date:</b>	08-JUN-2026
<b>Base Code</b>	ALQ26	<b>Team #:</b>	113
<b>Building #</b>	SDP-1-2-E	<b>System Voltage</b>	230/400
<b>Building Type</b>	SDP	<b>Inspection Phase</b>	Full Inspection
<b>Previous Report #:</b>	N/A	<b>Work Order:</b>	TFS-ALQ26-2026-00006

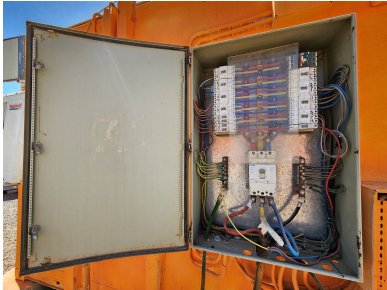
<b>Deficiency #1</b>	<b>RAC 2</b>	<b>Occurrences: 1</b>
----------------------	--------------	-----------------------

**Description:** SDP is unlisted.

<b>Location:</b>	Rear of kitchen.
<b>Category:</b>	Unlisted Equipment
<b>Equipment:</b>	SDP
<b>Imminent:</b>	No
<b>Action:</b>	N/A
<b>Assigned To:</b>	O&M; Provider
<b>Code:</b>	British Standard 511: Compliance with standards
<b>Status:</b>	Open

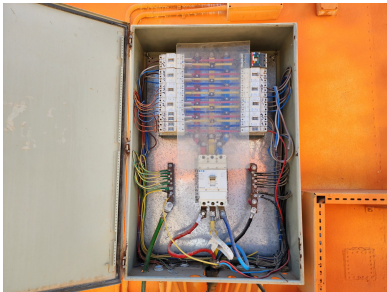
<b>Deficiency #2</b>	<b>RAC 2</b>	<b>Occurrences: 1</b>
----------------------	--------------	-----------------------

**Description:** There is no dead front within SDP. Door requires a key or a tool for access.

<b>Location:</b>	Within SDP.
<b>Category:</b>	Improper Use / Damaged
<b>Equipment:</b>	SDP
<b>Imminent:</b>	No
<b>Action:</b>	N/A
<b>Assigned To:</b>	O&M; Provider
<b>Code:</b>	British Standard 132: Protection against electric shock
<b>Status:</b>	Open

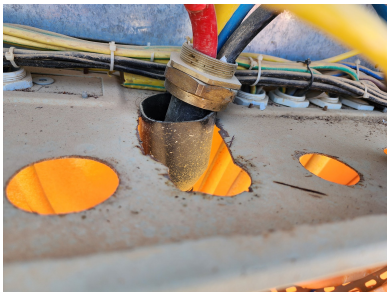
<b>Deficiency #3</b>	<b>RAC 2</b>	<b>Occurrences: 5</b>
----------------------	--------------	-----------------------

**Description:** Unused openings compromising integrity of IP rating.

<b>Location:</b>	Within SDP.
<b>Category:</b>	Improper Use / Damaged
<b>Equipment:</b>	SDP
<b>Imminent:</b>	No
<b>Action:</b>	N/A
<b>Assigned To:</b>	O&M; Provider
<b>Code:</b>	British Standard 522: Selection and erection of wiring systems in relation to external influences
<b>Status:</b>	Open

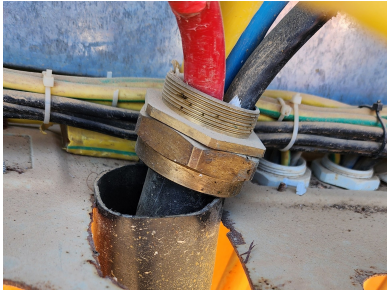
<b>Deficiency #4</b>	<b>RAC 3</b>	<b>Occurrences: 1</b>
----------------------	--------------	-----------------------

**Description:** SWA gland to main incoming supply cable is not fixed into position.

<b>Location:</b>	Within SDP.
<b>Category:</b>	Poor Workmanship
<b>Equipment:</b>	SDP
<b>Imminent:</b>	No
<b>Action:</b>	N/A
<b>Assigned To:</b>	O&M; Provider
<b>Code:</b>	British Standard 510: Common rules
<b>Status:</b>	Open

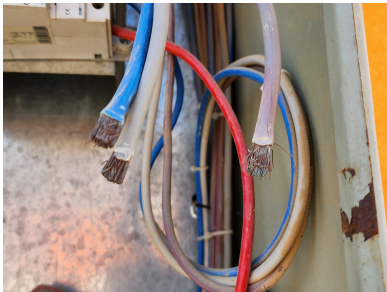
<b>Deficiency #5</b>	<b>RAC 3</b>	<b>Occurrences: 1</b>
----------------------	--------------	-----------------------

**Description:** Redundant outgoing circuit has bare ends left exposed. TF Safe made safe on the spot.

<b>Location:</b>	Within SDP.
<b>Category:</b>	Poor Workmanship
<b>Equipment:</b>	SDP
<b>Imminent:</b>	No
<b>Action:</b>	N/A
<b>Assigned To:</b>	Task Force SAFE
<b>Code:</b>	British Standard 510: Common rules
<b>Status:</b>	Closed / Repaired

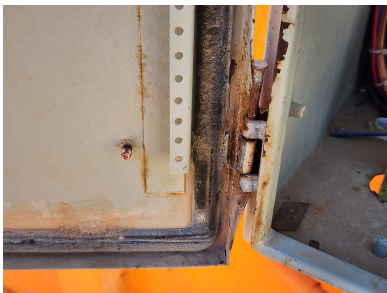
<b>Deficiency #6</b>	<b>RAC 2</b>	<b>Occurrences: 1</b>
----------------------	--------------	-----------------------

**Description:** No supplementary bond installed to door.

<b>Location:</b>	Within SDP.
<b>Category:</b>	Grounding and Bonding
<b>Equipment:</b>	SDP
<b>Imminent:</b>	No
<b>Action:</b>	N/A
<b>Assigned To:</b>	O&M; Provider
<b>Code:</b>	British Standard 542: Earthing arrangements
<b>Status:</b>	Open

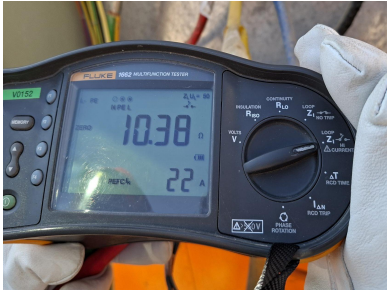
<b>Deficiency #7</b>	<b>RAC 2</b>	<b>Occurrences: 1</b>
----------------------	--------------	-----------------------

**Description:** Ze reading of 10.38 Ohms exceeds the maximum permitted tolerance of 0.8 Ohms.

<b>Location:</b>	Within SDP.
<b>Category:</b>	Grounding and Bonding
<b>Equipment:</b>	SDP
<b>Imminent:</b>	No
<b>Action:</b>	N/A
<b>Assigned To:</b>	O&M; Provider
<b>Code:</b>	British Standard 132: Protection against electric shock
<b>Status:</b>	Open

x 1 SDP. x 1 350A 3P MCCB. x 2 100A 3P MCCB's. x 2 63A 3P MCCB's. x 2 40A 3P MCCB's. x 1 50A 1P MCCB. x 1 25A 3P MCCB. x 4 20A 1P MCCB's. All cabling, terminations and earthing arrangements. Multiple outgoing circuits have not been crimped to MCCB's. Main earth is a 300mm<sup>2</sup> single core conductor terminated to a ground rod, resulting in high Ze readings.

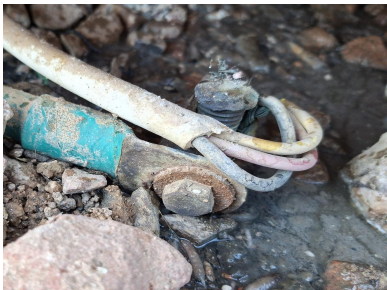
<b>Deficiency #8</b>	<b>RAC 2</b>	<b>Occurrences: 1</b>
----------------------	--------------	-----------------------

**Description:** CPC is terminated to ground electrode conductor.

<b>Location:</b>	Below SDP.
<b>Category:</b>	Grounding and Bonding
<b>Equipment:</b>	GND
<b>Imminent:</b>	No
<b>Action:</b>	N/A
<b>Assigned To:</b>	O&M; Provider
<b>Code:</b>	British Standard 542: Earthing arrangements
<b>Status:</b>	Open

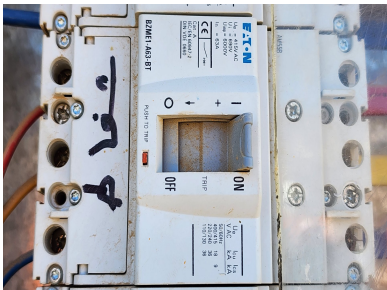
<b>Deficiency #9</b>	<b>RAC 2</b>	<b>Occurrences: 2</b>
----------------------	--------------	-----------------------

**Description:** Circuit 3/TP, 6mm<sup>2</sup> conductors fed from 63A MCCB. Circuit 9/TP, 16mm<sup>2</sup> conductors fed from 100A MCCB.

<b>Location:</b>	Within SDP.
<b>Category:</b>	Improper Use / Damaged
<b>Equipment:</b>	SDP
<b>Imminent:</b>	No
<b>Action:</b>	N/A
<b>Assigned To:</b>	O&M; Provider
<b>Code:</b>	British Standard Appx 4: Current carrying capacities and voltage drop for cables
<b>Status:</b>	Open
