Task Force SAFE

Inspection-Report_TFSAFE_Full_KFAB22_Oiltown-SIPR-120-208_116_08-06-26_0

Base Location	KFAB (Jordan)	Date:	08-JUN-2026
Base Code	KFAB22	Team #:	116
Building #	Oiltown-SIPR-120-208	System Voltage	120/208
Building Type	CDP	Inspection Phase	Full Inspection
Previous Report #:	N/A	Work Order:	TFS-KFAB22-2026-00009

Oiltown is adjacent to the airfield, north of Dufftown. The SIPR office is within Oiltown. The SIPR 120-208 is a power distribution point located within the SIPR office.

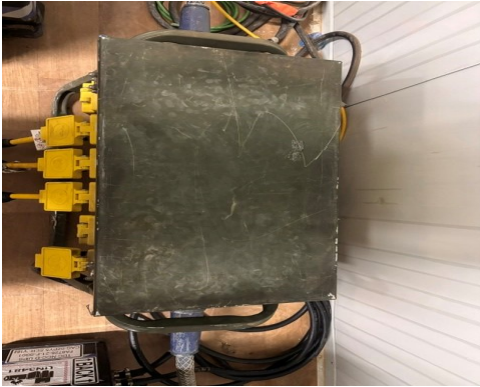
Overall Building Electrical System:**Building Picture:**

1x Power Distribution Point. All cables. GFCI breakers are functional and operational.
