Task Force SAFE

Inspection-Report_TFSAFE_Full_KFAB22_Oiltown-SIPR_116_08-06-26_1-6

Base Location	KFAB (Jordan)	Date:	08-JUN-2026
Base Code	KFAB22	Team #:	116
Building #	Oiltown-SIPR	System Voltage	230/400
Building Type	OFFICE	Inspection Phase	Full Inspection
Previous Report #:	N/A	Work Order:	TFS-KFAB22-2026-00008

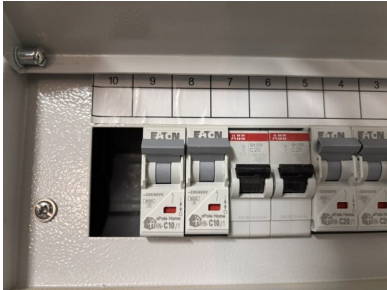
Deficiency #1	RAC 2	Occurrences: 1
----------------------	--------------	-----------------------

Description: Breaker blank missing from dead front.

Location:	At CDP.
Category:	Improper Use / Damaged
Equipment:	CDP
Imminent:	No
Action:	N/A
Assigned To:	O&M; Provider
Code:	British Standard 132: Protection against electric shock
Status:	Open

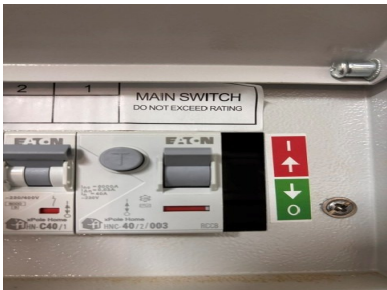
Deficiency #2	RAC 2	Occurrences: 1
----------------------	--------------	-----------------------

Description: Type AC RCD used. Type AC RCD is not suitable for this building.

Location:	Within the CDP.
Category:	Improper Use / Damaged
Equipment:	CDP
Imminent:	No
Action:	N/A
Assigned To:	O&M; Provider
Code:	British Standard 132: Protection against electric shock
Status:	Open

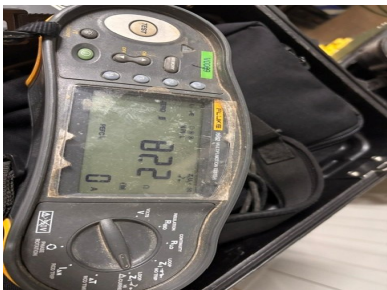
Deficiency #3	RAC 2	Occurrences: 6
----------------------	--------------	-----------------------

Description: High Zs reading of 822 ohms throughout the office.

Location:	All circuits.
Category:	Grounding and Bonding
Equipment:	WLT
Imminent:	No
Action:	N/A
Assigned To:	O&M; Provider
Code:	British Standard 542: Earthing arrangements
Status:	Open

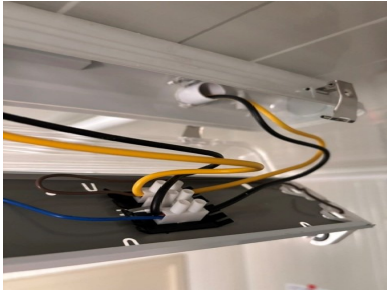
Deficiency #4	RAC 2	Occurrences: 1
----------------------	--------------	-----------------------

Description: No CPC to lighting circuit.

Location:	Within lighting circuit including switches.
Category:	Grounding and Bonding
Equipment:	LTG
Imminent:	No
Action:	N/A
Assigned To:	O&M; Provider
Code:	British Standard 542: Earthing arrangements
Status:	Open

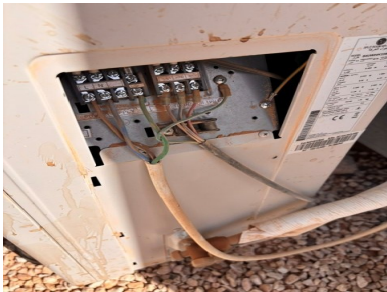
Deficiency #5	RAC 2	Occurrences: 2
----------------------	--------------	-----------------------

Description: Cable clips not used: strain on terminations.

Location:	At external AC condensers.
Category:	Improper Use / Damaged
Equipment:	WLT
Imminent:	No
Action:	N/A
Assigned To:	O&M; Provider
Code:	British Standard 522: Selection and erection of wiring systems in relation to external influences
Status:	Open

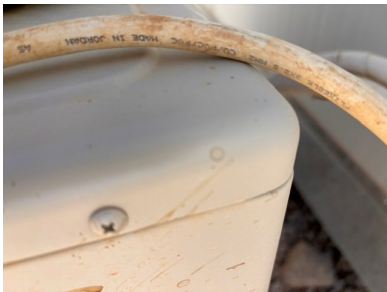
Deficiency #6	RAC 2	Occurrences: 2
----------------------	--------------	-----------------------

Description: Unlisted cables.

Location:	At external AC condensers.
Category:	Unlisted Equipment
Equipment:	WLT
Imminent:	No
Action:	N/A
Assigned To:	O&M; Provider
Code:	British Standard 511: Compliance with standards
Status:	Open
