Task Force SAFE

Inspection-Report_TFSAFE_Full_ALQ26_SDP-2-E_113_09-06-26_1-8

| Building # | SDP-2-E | System Voltage | 230/400 |
| Building Type | SDP | Inspection Phase | Full Inspection |

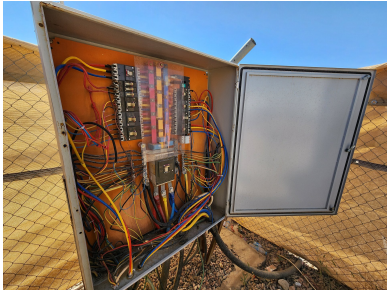
| Deficiency #1 | RAC 2 | Occurrences: 1 |

Description: SDP-2-E is unlisted.

| Location: | Northeast perimeter behind kitchen. |
| Category: | Unlisted Equipment |
| Code: | British Standard 511: Compliance with standards |

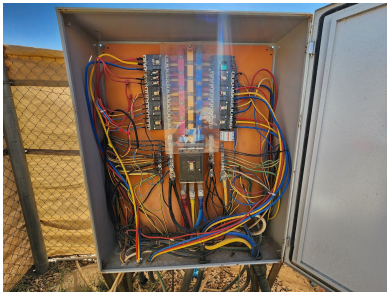
| Deficiency #2 | RAC 2 | Occurrences: 1 |

Description: No dead front present within SDP. Access requires a key or a tool.

| Location: | Within SDP. |
| Category: | Improper Use / Damaged |
| Code: | British Standard 132: Protection against electric shock |

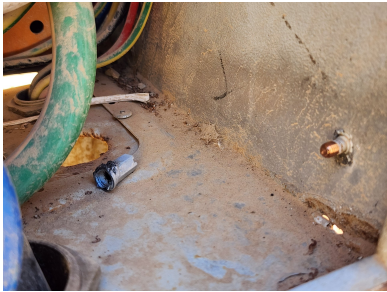
| Deficiency #3 | RAC 2 | Occurrences: 1 |

Description: No supplementary bond present to enclosure.

| Location: | Within SDP. |
| Category: | Grounding and Bonding |
| Code: | British Standard 542: Earthing arrangements |

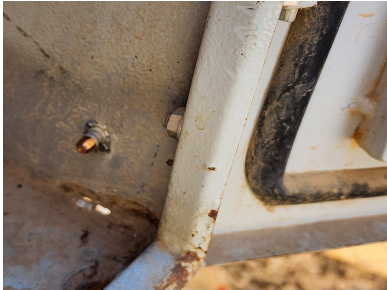
| Deficiency #4 | RAC 2 | Occurrences: 1 |

Description: No supplementary bond present to door.

| Location: | Within SDP. |
| Category: | Grounding and Bonding |
| Code: | British Standard 542: Earthing arrangements |

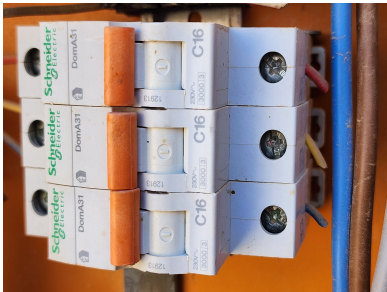
| Deficiency #5 | RAC 3 | Occurrences: 1 |

Description: Redundant exposed live conductors have been left terminated to the outgoing side of overcurrent protective devices.

| Location: | Within SDP. |
| Category: | Poor Workmanship |
| Code: | British Standard 132: Protection against electric shock |

| Status: | Closed / Repaired |

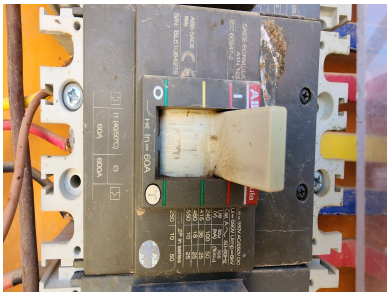
| Deficiency #6 | RAC 2 | Occurrences: 2 |

Description: 6mm² and 2.5mm² conductors fed from the same 60A MCCB.

| Location: | Within SDP, circuit 3/TP. |
| Category: | Improper Use / Damaged |
| Code: | British Standard Appx 4: Current carrying capacities and voltage drop for cables |

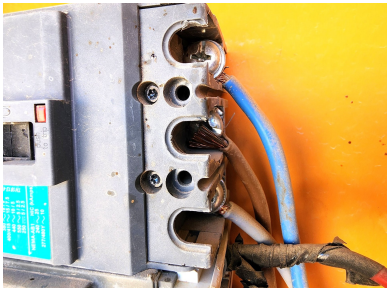
| Deficiency #7 | RAC 2 | Occurrences: 1 |

Description: Outgoing conductor L2 is only 50% captured under terminal screw.

| Location: | Within SDP, circuit 6/TP. |
| Category: | Improper Terminations |
| Code: | British Standard 526: Electrical connections |

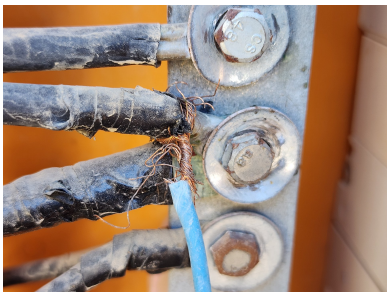
| Deficiency #8 | RAC 2 | Occurrences: 1 |

Description: The neutral conductor has been wrapped around the neutral bar to form a connection.

| Location: | Within SDP, circuit 3/TP, neutral conductor. |
| Category: | Improper Terminations |
| Code: | British Standard 526: Electrical connections |
