Task Force SAFE

Inspection-Report_TFSAFE_Full_KFAB22_Oiltown-EC-130-MX_116_09-06-26_1-6

Base Location	KFAB (Jordan)	Date:	09-JUN-2026
Base Code	KFAB22	Team #:	116
Building #	Oiltown-EC-130-MX	System Voltage	230/400
Building Type	OFFICE	Inspection Phase	Full Inspection
Previous Report #:	N/A	Work Order:	TFS-KFAB22-2026-00010

Oiltown is adjacent to the airfield, north of Dufftown. The EC-130 MX office is within Oiltown.

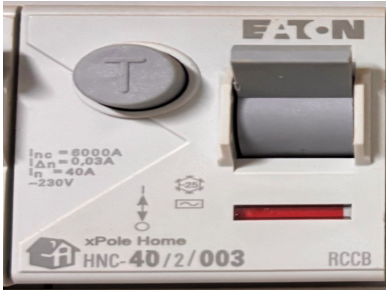
Deficiency #1	RAC 2	Occurrences: 1
----------------------	--------------	-----------------------

Description: Type AC RCD used. Type AC RCD is not suitable for this building.

Location:	Within the CDP.
Category:	Improper Use / Damaged
Equipment:	CDP
Imminent:	No
Action:	N/A
Assigned To:	O&M; Provider
Code:	British Standard 132: Protection against electric shock
Status:	Open

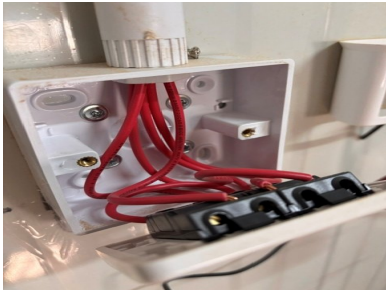
Deficiency #2	RAC 2	Occurrences: 2
----------------------	--------------	-----------------------

Description: No CPC to switches.

Location:	At wall switches near entrances.
Category:	Grounding and Bonding
Equipment:	WLT
Imminent:	No
Action:	N/A
Assigned To:	O&M; Provider
Code:	British Standard 542: Earthing arrangements
Status:	Open

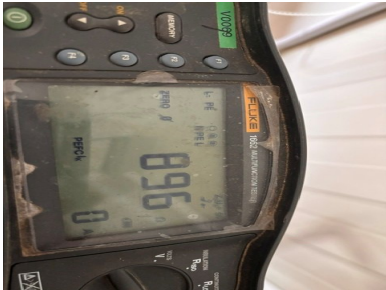
Deficiency #3	RAC 2	Occurrences: 6
----------------------	--------------	-----------------------

Description: High Zs reading of 896 ohms throughout office.

Location:	All circuits.
Category:	Grounding and Bonding
Equipment:	WLT
Imminent:	No
Action:	N/A
Assigned To:	O&M; Provider
Code:	British Standard 542: Earthing arrangements
Status:	Open

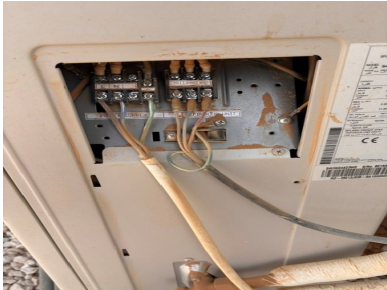
Deficiency #4	RAC 2	Occurrences: 2
----------------------	--------------	-----------------------

Description: Cable clips not used: strain on terminations.

Location:	At external AC condensers.
Category:	Improper Use / Damaged
Equipment:	WLT
Imminent:	No
Action:	N/A
Assigned To:	O&M; Provider
Code:	British Standard 522: Selection and erection of wiring systems in relation to external influences
Status:	Open

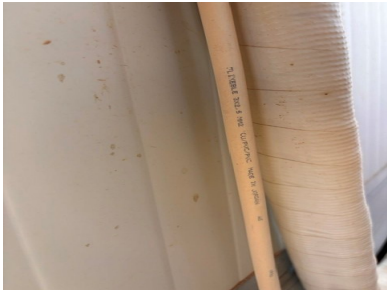
Deficiency #5	RAC 2	Occurrences: 2
----------------------	--------------	-----------------------

Description: Unlisted cables.

Location:	At external AC condensers.
Category:	Unlisted Equipment
Equipment:	WLT
Imminent:	No
Action:	N/A
Assigned To:	O&M; Provider
Code:	British Standard 511: Compliance with standards
Status:	Open

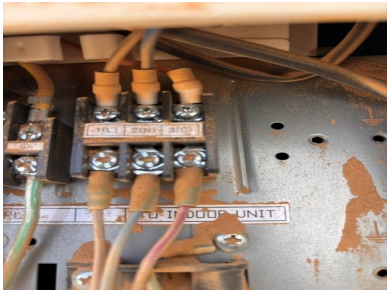
Deficiency #6	RAC 2	Occurrences: 2
----------------------	--------------	-----------------------

Description: Loose terminations on the neutral. (Buzzing noise heard on both AC condensers) Repaired on the spot by TF SAFE.

Location:	At external AC condensers.
Category:	Improper Terminations
Equipment:	WLT
Imminent:	No
Action:	N/A
Assigned To:	Task Force SAFE
Code:	British Standard 642: Inspection
Status:	Closed / Repaired
