## Task Force SAFE

**Inspection-Report\_TFSAFE\_Full\_ALQ26\_SDP-2-1-E\_113\_10-06-26\_1-8**

<b>Base Location</b>	Al Quwayrah	<b>Date:</b>	10-JUN-2026
<b>Base Code</b>	ALQ26	<b>Team #:</b>	113
<b>Building #</b>	SDP-2-1-E	<b>System Voltage</b>	230/400
<b>Building Type</b>	SDP	<b>Inspection Phase</b>	Full Inspection
<b>Previous Report #:</b>	N/A	<b>Work Order:</b>	TFS-ALQ26-2026-00008

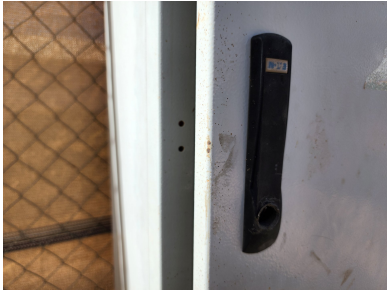
<b>Deficiency #1</b>	<b>RAC 1</b>	<b>Occurrences: 1</b>
----------------------	--------------	-----------------------

**Description:** Locking mechanism to SDP is damaged, allowing access to live parts.

<b>Location:</b>	South of reefer units.
<b>Category:</b>	Improper Use / Damaged
<b>Equipment:</b>	SDP
<b>Imminent:</b>	Yes
<b>Action:</b>	Makeshift lock installed, signs in place and personnel informed.
<b>Assigned To:</b>	O&M; Provider
<b>Code:</b>	British Standard 132: Protection against electric shock
<b>Status:</b>	Open

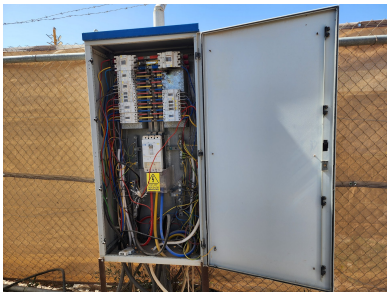
<b>Deficiency #2</b>	<b>RAC 2</b>	<b>Occurrences: 1</b>
----------------------	--------------	-----------------------

**Description:** SDP-2-1-E is unlisted.

<b>Location:</b>	South of reefer units.
<b>Category:</b>	Unlisted Equipment
<b>Equipment:</b>	SDP
<b>Imminent:</b>	No
<b>Action:</b>	N/A
<b>Assigned To:</b>	O&M; Provider
<b>Code:</b>	British Standard 511: Compliance with standards
<b>Status:</b>	Open

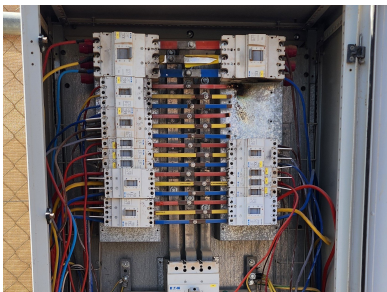
<b>Deficiency #3</b>	<b>RAC 2</b>	<b>Occurrences: 1</b>
----------------------	--------------	-----------------------

**Description:** Dead front is missing, allowing access to live parts.

<b>Location:</b>	Within SDP.
<b>Category:</b>	Improper Use / Damaged
<b>Equipment:</b>	SDP
<b>Imminent:</b>	No
<b>Action:</b>	N/A
<b>Assigned To:</b>	O&M; Provider
<b>Code:</b>	British Standard 132: Protection against electric shock
<b>Status:</b>	Open

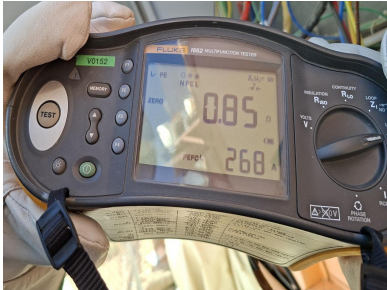
<b>Deficiency #4</b>	<b>RAC 2</b>	<b>Occurrences: 1</b>
----------------------	--------------	-----------------------

**Description:** Ze reading of 0.85 Ohms exceeds the maximum permitted tolerance of 0.8 Ohms.

<b>Location:</b>	Within SDP.
<b>Category:</b>	Grounding and Bonding
<b>Equipment:</b>	SDP
<b>Imminent:</b>	No
<b>Action:</b>	N/A
<b>Assigned To:</b>	O&M; Provider
<b>Code:</b>	British Standard 132: Protection against electric shock
<b>Status:</b>	Open

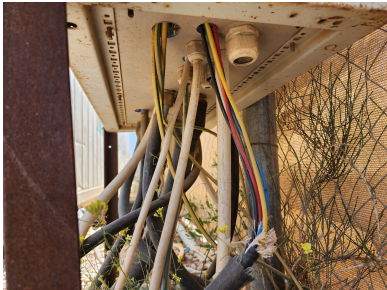
<b>Deficiency #5</b>	<b>RAC 3</b>	<b>Occurrences: 1</b>
----------------------	--------------	-----------------------

**Description:** Exposed 3 phase single insulated conductors to outgoing circuit 12/TP.

<b>Location:</b>	Outgoing circuits 12/TP, bottom of SDP.
<b>Category:</b>	Poor Workmanship
<b>Equipment:</b>	SDP
<b>Imminent:</b>	No
<b>Action:</b>	N/A
<b>Assigned To:</b>	O&M; Provider
<b>Code:</b>	British Standard 642: Inspection
<b>Status:</b>	Open

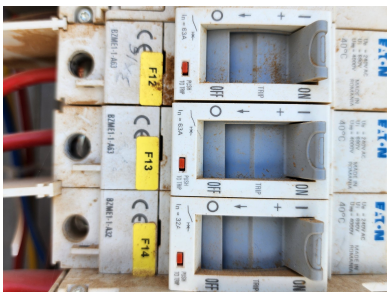
<b>Deficiency #6</b>	<b>RAC 2</b>	<b>Occurrences: 6</b>
----------------------	--------------	-----------------------

**Description:** Circuit 1/TP - 16mm<sup>2</sup> conductors fed from 125A MCCB. Circuit 2/TP - 10mm<sup>2</sup> conductors fed from 63A MCCB. Circuit 4/L1 - 10mm<sup>2</sup> conductors fed from 63A MCCB. Circuit 4/L2 - 10mm<sup>2</sup> conductors fed from 63A MCCB. Circuit 4/L3 - 2.5mm<sup>2</sup> conductors fed from 32A MCCB. Circuit 7/TP - 10mm<sup>2</sup> conductors fed from 125A MCCB.

<b>Location:</b>	Within SDP.
<b>Category:</b>	Improper Use / Damaged
<b>Equipment:</b>	SDP
<b>Imminent:</b>	No
<b>Action:</b>	N/A
<b>Assigned To:</b>	O&M; Provider
<b>Code:</b>	British Standard Appx 4: Current carrying capacities and voltage drop for cables
<b>Status:</b>	Open

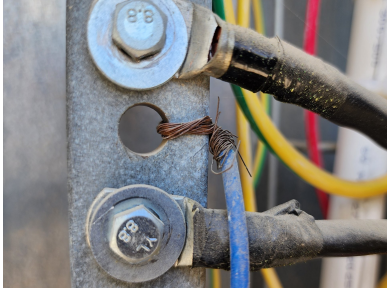
<b>Deficiency #7</b>	<b>RAC 2</b>	<b>Occurrences: 4</b>
----------------------	--------------	-----------------------

**Description:** Neutral and CPC conductors have been twisted around the neutral and MET bars to form a connection.

<b>Location:</b>	Within SDP, circuits 4/L3 and 11/L3.
<b>Category:</b>	Improper Terminations
<b>Equipment:</b>	SDP
<b>Imminent:</b>	No
<b>Action:</b>	N/A
<b>Assigned To:</b>	O&M; Provider
<b>Code:</b>	British Standard 526: Electrical connections
<b>Status:</b>	Open

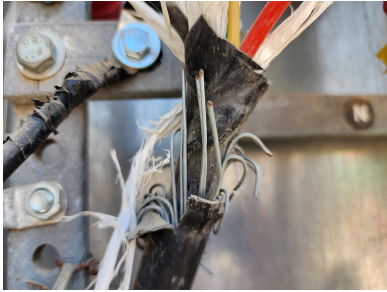
<b>Deficiency #8</b>	<b>RAC 3</b>	<b>Occurrences: 3</b>
----------------------	--------------	-----------------------

**Description:** Outgoing circuits 5/TP, 11/L3 and 12/TP have not been glanded.

<b>Location:</b>	Outgoing circuits 5/TP, 11/L3 and 12/TP.
<b>Category:</b>	Poor Workmanship
<b>Equipment:</b>	SDP
<b>Imminent:</b>	No
<b>Action:</b>	N/A
<b>Assigned To:</b>	O&M; Provider
<b>Code:</b>	British Standard 510: Common rules
<b>Status:</b>	Open
