Task Force SAFE

Inspection-Report_TFSAFE_Full_KFAB22_Oiltown-EC-130-OPS_116_10-06-26_1-6

Base Location	KFAB (Jordan)	Date:	10-JUN-2026
Base Code	KFAB22	Team #:	116
Building #	Oiltown-EC-130-OPS	System Voltage	230/400
Building Type	OFFICE	Inspection Phase	Full Inspection
Previous Report #:	N/A	Work Order:	TFS-KFAB22-2026-00011

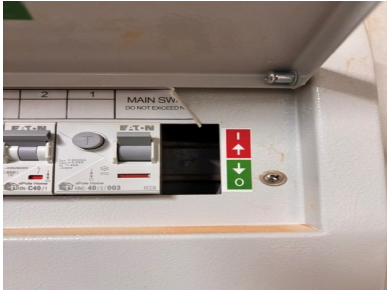
Deficiency #1	RAC 2	Occurrences: 1
----------------------	--------------	-----------------------

Description: Breaker blank missing from dead front.

Location:	At CDP.
Category:	Improper Use / Damaged
Equipment:	CDP
Imminent:	No
Action:	N/A
Assigned To:	O&M; Provider
Code:	British Standard 132: Protection against electric shock
Status:	Open

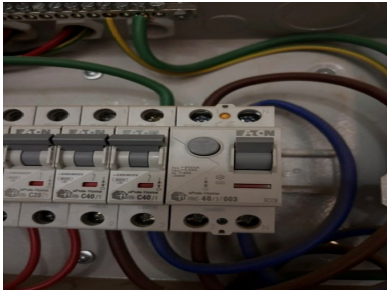
Deficiency #2	RAC 2	Occurrences: 1
----------------------	--------------	-----------------------

Description: Type AC RCD used. Type AC RCD is not suitable for this building.

Location:	Within the CDP.
Category:	Improper Use / Damaged
Equipment:	CDP
Imminent:	No
Action:	N/A
Assigned To:	O&M; Provider
Code:	British Standard 132: Protection against electric shock
Status:	Open

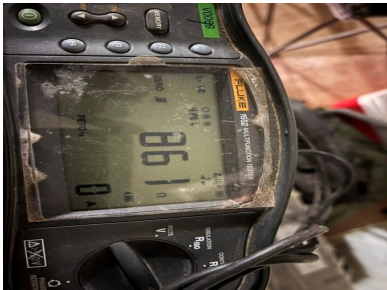
Deficiency #3	RAC 2	Occurrences: 6
----------------------	--------------	-----------------------

Description: High Zs reading of 861 ohms throughout the office.

Location:	All circuits.
Category:	Grounding and Bonding
Equipment:	WLT
Imminent:	No
Action:	N/A
Assigned To:	O&M; Provider
Code:	British Standard 542: Earthing arrangements
Status:	Open

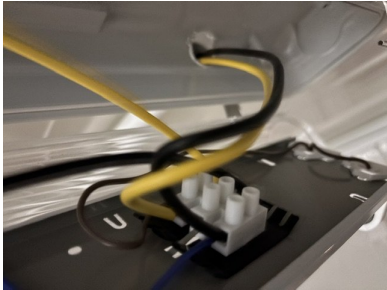
Deficiency #4	RAC 2	Occurrences: 1
----------------------	--------------	-----------------------

Description: No CPC to lighting circuit.

Location:	Within lighting circuit including switches.
Category:	Grounding and Bonding
Equipment:	LTG
Imminent:	No
Action:	N/A
Assigned To:	O&M; Provider
Code:	British Standard 542: Earthing arrangements
Status:	Open

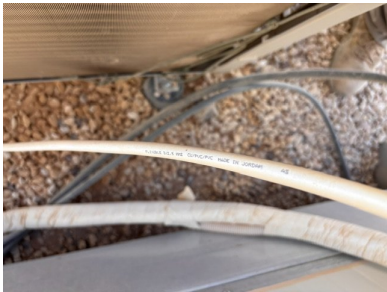
Deficiency #5	RAC 2	Occurrences: 2
----------------------	--------------	-----------------------

Description: Unlisted cables.

Location:	At external AC condensers.
Category:	Unlisted Equipment
Equipment:	WLT
Imminent:	No
Action:	N/A
Assigned To:	O&M; Provider
Code:	British Standard 511: Compliance with standards
Status:	Open

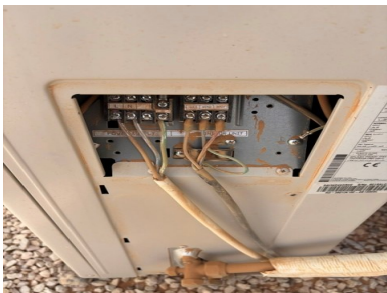
Deficiency #6	RAC 2	Occurrences: 2
----------------------	--------------	-----------------------

Description: Cable clips not used: strain on terminations.

Location:	At external AC condensers.
Category:	Improper Use / Damaged
Equipment:	WLT
Imminent:	No
Action:	N/A
Assigned To:	O&M; Provider
Code:	British Standard 522: Selection and erection of wiring systems in relation to external influences
Status:	Open
