## Task Force SAFE

**Inspection-Report\_TFSAFE\_Full\_ALQ26\_SDP-2-2-E\_113\_11-06-26\_1-8**

<b>Base Location</b>	Al Quwayrah	<b>Date:</b>	11-JUN-2026
<b>Base Code</b>	ALQ26	<b>Team #:</b>	113
<b>Building #</b>	SDP-2-2-E	<b>System Voltage</b>	230/400
<b>Building Type</b>	SDP	<b>Inspection Phase</b>	Full Inspection
<b>Previous Report #:</b>	N/A	<b>Work Order:</b>	TFS-ALQ26-2026-00009

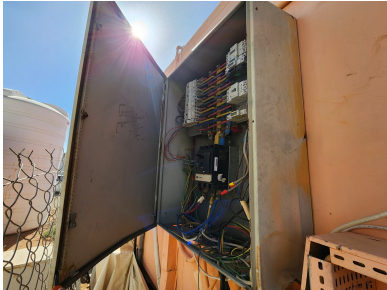
<b>Deficiency #1</b>	<b>RAC 2</b>	<b>Occurrences: 1</b>
----------------------	--------------	-----------------------

**Description:** SDP-2-2-E is unlisted.

<b>Location:</b>	Opposite water tanks, northeast perimeter.
<b>Category:</b>	Unlisted Equipment
<b>Equipment:</b>	SDP
<b>Imminent:</b>	No
<b>Action:</b>	N/A
<b>Assigned To:</b>	O&M; Provider
<b>Code:</b>	British Standard 511: Compliance with standards
<b>Status:</b>	Open

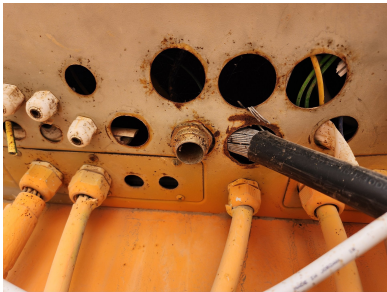
<b>Deficiency #2</b>	<b>RAC 2</b>	<b>Occurrences: 10</b>
----------------------	--------------	------------------------

**Description:** Unused openings are compromising the integrity of IP rating.

<b>Location:</b>	Bottom of SDP.
<b>Category:</b>	Improper Use / Damaged
<b>Equipment:</b>	SDP
<b>Imminent:</b>	No
<b>Action:</b>	N/A
<b>Assigned To:</b>	O&M; Provider
<b>Code:</b>	British Standard 522: Selection and erection of wiring systems in relation to external influences
<b>Status:</b>	Open

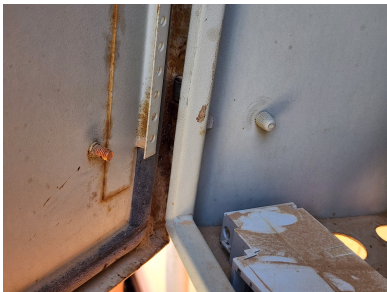
<b>Deficiency #3</b>	<b>RAC 2</b>	<b>Occurrences: 1</b>
----------------------	--------------	-----------------------

**Description:** No supplementary bond present to door.

<b>Location:</b>	Within SDP.
<b>Category:</b>	Grounding and Bonding
<b>Equipment:</b>	SDP
<b>Imminent:</b>	No
<b>Action:</b>	N/A
<b>Assigned To:</b>	O&M; Provider
<b>Code:</b>	British Standard 542: Earthing arrangements
<b>Status:</b>	Open

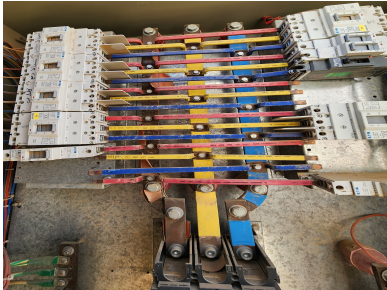
<b>Deficiency #4</b>	<b>RAC 2</b>	<b>Occurrences: 1</b>
----------------------	--------------	-----------------------

**Description:** No dead front within SDP. Access requires the use of a key or a tool.

<b>Location:</b>	Within SDP.
<b>Category:</b>	Improper Use / Damaged
<b>Equipment:</b>	SDP
<b>Imminent:</b>	No
<b>Action:</b>	N/A
<b>Assigned To:</b>	O&M; Provider
<b>Code:</b>	British Standard 132: Protection against electric shock
<b>Status:</b>	Open

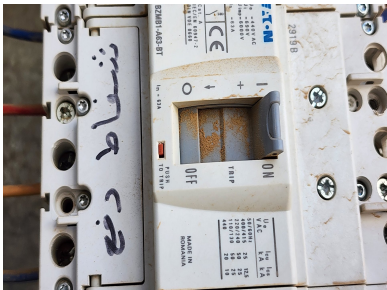
<b>Deficiency #5</b>	<b>RAC 2</b>	<b>Occurrences: 8</b>
----------------------	--------------	-----------------------

**Description:** Circuit 1/TP and 2/TP - 4mm<sup>2</sup> conductors fed from 63A MCCB's. Circuit 3/TP, 4/TP, 6/TP and 9/TP - 10mm<sup>2</sup> conductors fed from 63A MCCB's. Circuit 5/L1 and 7/L2 - 2.5mm<sup>2</sup> conductors fed from 63A MCCB's.

<b>Location:</b>	Within SDP.
<b>Category:</b>	Improper Use / Damaged
<b>Equipment:</b>	SDP
<b>Imminent:</b>	No
<b>Action:</b>	N/A
<b>Assigned To:</b>	O&M; Provider
<b>Code:</b>	British Standard Appx 4: Current carrying capacities and voltage drop for cables
<b>Status:</b>	Open

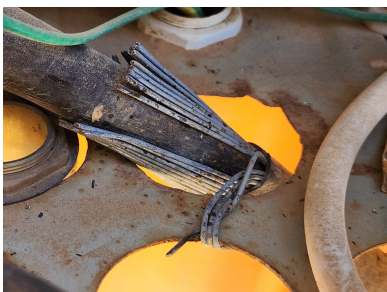
<b>Deficiency #6</b>	<b>RAC 2</b>	<b>Occurrences: 1</b>
----------------------	--------------	-----------------------

**Description:** Main supply has not been glanded.

<b>Location:</b>	Within SDP.
<b>Category:</b>	Grounding and Bonding
<b>Equipment:</b>	SDP
<b>Imminent:</b>	No
<b>Action:</b>	N/A
<b>Assigned To:</b>	O&M; Provider
<b>Code:</b>	British Standard 542: Earthing arrangements
<b>Status:</b>	Open

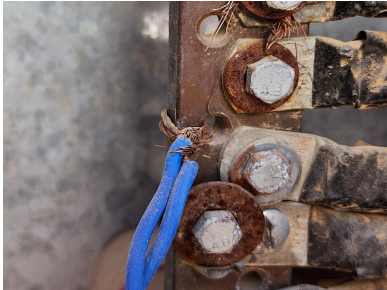
<b>Deficiency #7</b>	<b>RAC 2</b>	<b>Occurrences: 4</b>
----------------------	--------------	-----------------------

**Description:** CPC and neutral conductors have been wrapped around the neutral and MET bars to form a connection.

<b>Location:</b>	Within SDP, circuit 5/L1 and 7/L2.
<b>Category:</b>	Improper Terminations
<b>Equipment:</b>	SDP
<b>Imminent:</b>	No
<b>Action:</b>	N/A
<b>Assigned To:</b>	O&M; Provider
<b>Code:</b>	British Standard 526: Electrical connections
<b>Status:</b>	Open

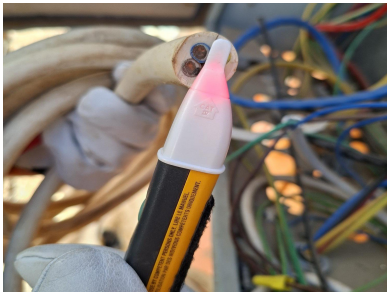
<b>Deficiency #8</b>	<b>RAC 1</b>	<b>Occurrences: 1</b>
----------------------	--------------	-----------------------

**Description:** Redundant outgoing circuit has live bare ends left exposed. TF Safe made safe on the spot.

<b>Location:</b>	Within SDP, circuit 7/L3.
<b>Category:</b>	Poor Workmanship
<b>Equipment:</b>	SDP
<b>Imminent:</b>	Yes
<b>Action:</b>	Circuit 7/L3 isolated and ends made safe.
<b>Assigned To:</b>	Task Force SAFE
<b>Code:</b>	British Standard 510: Common rules
<b>Status:</b>	Closed / Repaired
