Task Force SAFE

Inspection-Report_TFSAFE_Full_KFAB22_Oiltown-Scorpion-OPS_116_11-06-26_1-

Base Location	KFAB (Jordan)	Date:	11-JUN-2026
Base Code	KFAB22	Team #:	116
Building #	Oiltown-Scorpion-OPS	System Voltage	230/400
Building Type	OFFICE	Inspection Phase	Full Inspection
Previous Report #:	N/A	Work Order:	TFS-KFAB22-2026-00012

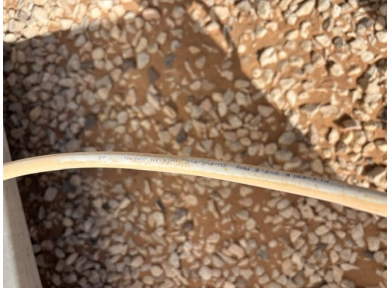
Deficiency #7	RAC 2	Occurrences: 2
----------------------	--------------	-----------------------

Description: Unlisted cables.

Location:	At external AC condensers.
Category:	Unlisted Equipment
Equipment:	WLT
Imminent:	No
Action:	N/A
Assigned To:	O&M; Provider
Code:	British Standard 511: Compliance with standards
Status:	Open

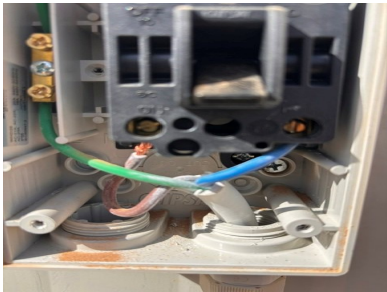
Deficiency #8	RAC 2	Occurrences: 1
----------------------	--------------	-----------------------

Description: Loose termination to load side live wire. TF SAFE repaired on the spot.

Location:	At external AC isolator #1.
Category:	Improper Terminations
Equipment:	WLT
Imminent:	No
Action:	N/A
Assigned To:	Task Force SAFE
Code:	British Standard 526: Electrical connections
Status:	Closed / Repaired
