## Task Force SAFE

# Inspection-Report\_TFSAFE\_Full\_5VN8M\_1404\_128\_12-06-26\_1

<b>Base Location</b>	JTC (Jordan)	<b>Date:</b>	12-JUN-2026
<b>Base Code</b>	5VN8M	<b>Team #:</b>	128
<b>Building #</b>	1404	<b>System Voltage</b>	230/400
<b>Building Type</b>	LSAU	<b>Inspection Phase</b>	Full Inspection
<b>Previous Report #:</b>	N/A	<b>Work Order:</b>	TFS-5VN8M-2026-00002

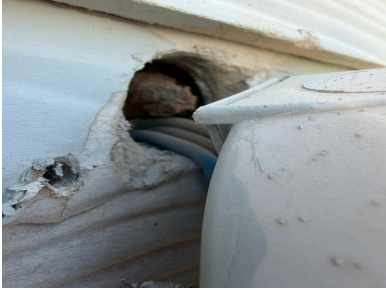
<b>Deficiency #1</b>	<b>RAC 2</b>	<b>Occurrences: 1</b>
----------------------	--------------	-----------------------

**Description:** No mechanical protection for single cables passing through building structure.

<b>Location:</b>	Outside light fixture above entrance door.
<b>Category:</b>	Improper Use / Damaged
<b>Equipment:</b>	WLT
<b>Imminent:</b>	No
<b>Action:</b>	N/A
<b>Assigned To:</b>	O&M; Provider
<b>Code:</b>	British Standard 522: Selection and erection of wiring systems in relation to external influences
<b>Status:</b>	Open
