Task Force SAFE

Inspection-Report_TFSAFE_Full_ALQ26_SDP-3-N_113_12-06-26_1-6

Base Location	Al Quwayrah	Date:	12-JUN-2026
Base Code	ALQ26	Team #:	113
Building #	SDP-3-N	System Voltage	230/400
Building Type	SDP	Inspection Phase	Full Inspection
Previous Report #:	N/A	Work Order:	TFS-ALQ26-2026-00010

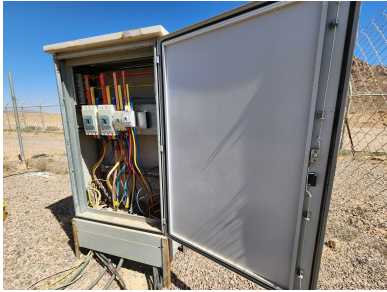
Deficiency #1	RAC 2	Occurrences: 1
----------------------	--------------	-----------------------

Description: SDP-3-N is unlisted.

Location:	Located behind gym on the northern perimeter.
Category:	Unlisted Equipment
Equipment:	SDP
Imminent:	No
Action:	N/A
Assigned To:	O&M; Provider
Code:	British Standard 511: Compliance with standards
Status:	Open

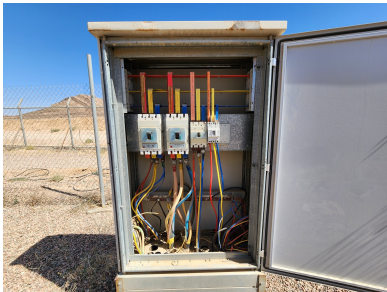
Deficiency #2	RAC 2	Occurrences: 1
----------------------	--------------	-----------------------

Description: No dead front present within SDP. Access requires the use of a key or a tool.

Location:	Within SDP.
Category:	Improper Use / Damaged
Equipment:	SDP
Imminent:	No
Action:	N/A
Assigned To:	O&M; Provider
Code:	British Standard 132: Protection against electric shock
Status:	Open

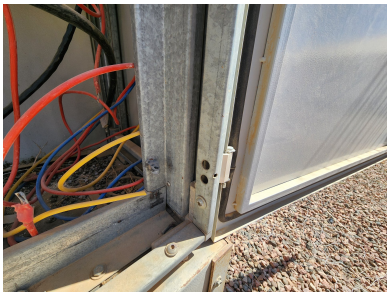
Deficiency #3	RAC 2	Occurrences: 1
----------------------	--------------	-----------------------

Description: No supplementary bond present to door.

Location:	Within SDP.
Category:	Grounding and Bonding
Equipment:	SDP
Imminent:	No
Action:	N/A
Assigned To:	O&M; Provider
Code:	British Standard 542: Earthing arrangements
Status:	Open

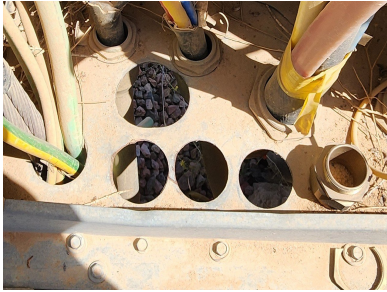
Deficiency #4	RAC 2	Occurrences: 5
----------------------	--------------	-----------------------

Description: Unused openings compromising integrity of IP rating.

Location:	Within SDP.
Category:	Improper Use / Damaged
Equipment:	SDP
Imminent:	No
Action:	N/A
Assigned To:	O&M; Provider
Code:	British Standard 522: Selection and erection of wiring systems in relation to external influences
Status:	Open

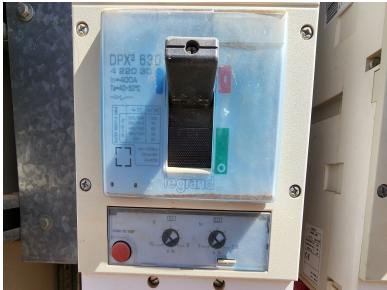
Deficiency #5	RAC 2	Occurrences: 2
----------------------	--------------	-----------------------

Description: Circuit 1/TP - 35mm² conductors in parallel fed from 400A MCCB. Circuit 2/TP - 35mm² conductors fed from 250A MCCB.

Location:	Within SDP.
Category:	Improper Use / Damaged
Equipment:	SDP
Imminent:	No
Action:	N/A
Assigned To:	O&M; Provider
Code:	British Standard Appx 4: Current carrying capacities and voltage drop for cables
Status:	Open

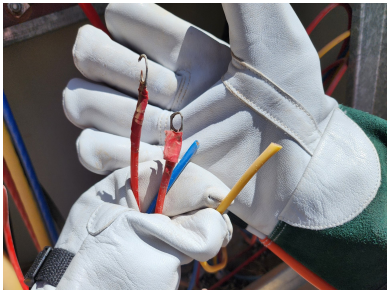
Deficiency #6	RAC 3	Occurrences: 2
----------------------	--------------	-----------------------

Description: Redundant outgoing circuits have bare ends left exposed.

Location:	Within SDP.
Category:	Poor Workmanship
Equipment:	SDP
Imminent:	No
Action:	N/A
Assigned To:	Task Force SAFE
Code:	British Standard 510: Common rules
Status:	Closed / Repaired
