Task Force SAFE

Inspection-Report_TFSAFE_Full_KFAB22_Oiltown-Fire-Breakroom_116_12-06-26_1

Base Location	KFAB (Jordan)	Date:	12-JUN-2026
Base Code	KFAB22	Team #:	116
Building #	Oiltown-Fire-Breakroom	System Voltage	230/400
Building Type	COMMON AREA	Inspection Phase	Full Inspection
Previous Report #:	N/A	Work Order:	TFS-KFAB22-2026-00013

Overall Building Electrical System: Fair

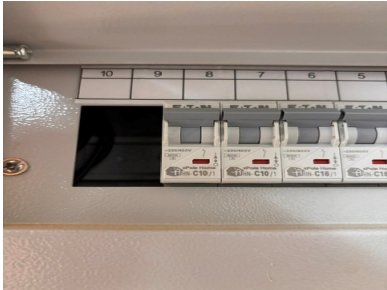
Deficiency #1	RAC 2	Occurrences: 2
----------------------	--------------	-----------------------

Description: Breaker blanks missing from dead front.

Location:	At CDP.
Category:	Improper Use / Damaged
Equipment:	CDP
Imminent:	No
Action:	N/A
Assigned To:	O&M; Provider
Code:	British Standard 132: Protection against electric shock
Status:	Open

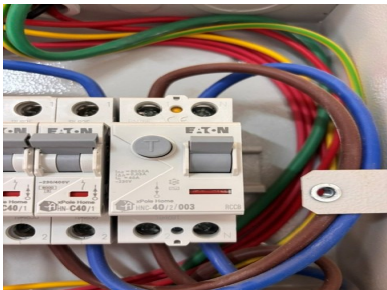
Deficiency #2	RAC 2	Occurrences: 1
----------------------	--------------	-----------------------

Description: Type AC RCD used. Type AC RCD is not suitable for this building.

Location:	Within the CDP.
Category:	Improper Use / Damaged
Equipment:	CDP
Imminent:	No
Action:	N/A
Assigned To:	O&M; Provider
Code:	British Standard 132: Protection against electric shock
Status:	Open

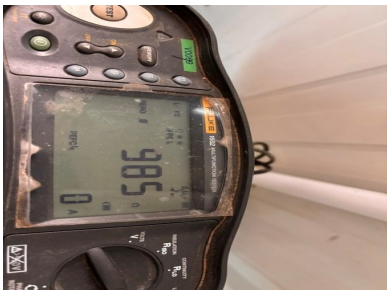
Deficiency #3	RAC 2	Occurrences: 6
----------------------	--------------	-----------------------

Description: High Zs reading of 985 ohms throughout breakroom.

Location:	All circuits.
Category:	Grounding and Bonding
Equipment:	WLT
Imminent:	No
Action:	N/A
Assigned To:	O&M; Provider
Code:	British Standard 542: Earthing arrangements
Status:	Open

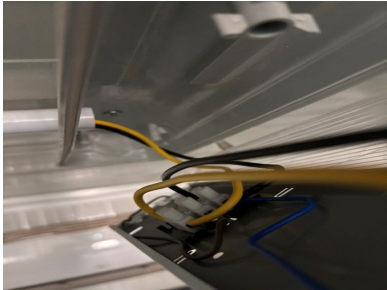
Deficiency #4	RAC 2	Occurrences: 1
----------------------	--------------	-----------------------

Description: No CPC to lighting circuit.

Location:	Within lighting circuit including switches.
Category:	Grounding and Bonding
Equipment:	LTG
Imminent:	No
Action:	N/A
Assigned To:	O&M; Provider
Code:	British Standard 542: Earthing arrangements
Status:	Open

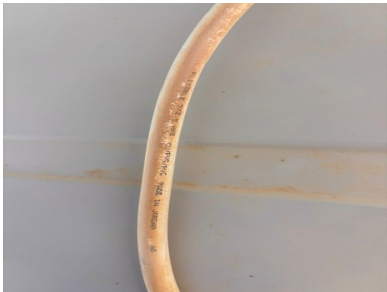
Deficiency #5	RAC 2	Occurrences: 2
----------------------	--------------	-----------------------

Description: Unlisted cables.

Location:	At external AC condensers.
Category:	Unlisted Equipment
Equipment:	WLT
Imminent:	No
Action:	N/A
Assigned To:	O&M; Provider
Code:	British Standard 511: Compliance with standards
Status:	Open

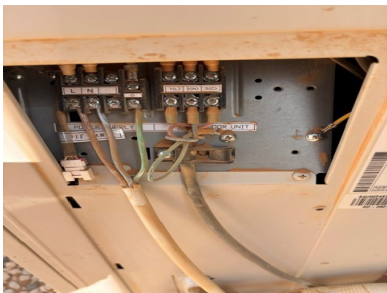
Deficiency #6	RAC 2	Occurrences: 2
----------------------	--------------	-----------------------

Description: Cable clips not used: strain on terminations.

Location:	At external AC condensers.
Category:	Improper Use / Damaged
Equipment:	WLT
Imminent:	No
Action:	N/A
Assigned To:	O&M; Provider
Code:	British Standard 522: Selection and erection of wiring systems in relation to external influences
Status:	Open
