## Task Force SAFE

**Inspection-Report\_TFSAFE\_Full\_KFAB22\_Oiltown-SDP-1\_116\_01-06-26\_1-4**

<b>Base Location</b>	KFAB (Jordan)	<b>Date:</b>	01-JUN-2026
<b>Base Code</b>	KFAB22	<b>Team #:</b>	116
<b>Building #</b>	Oiltown-SDP-1	<b>System Voltage</b>	230/400
<b>Building Type</b>	SDP	<b>Inspection Phase</b>	Full Inspection
<b>Previous Report #:</b>	N/A	<b>Work Order:</b>	TFS-KFAB22-2026-00001

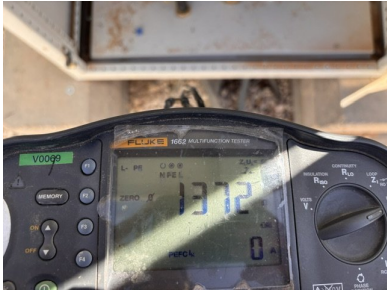
<b>Deficiency #1</b>	<b>RAC 1</b>	<b>Occurrences: 1</b>
----------------------	--------------	-----------------------

**Description:** High Zdb reading of 1372 ohms within the SDP.

<b>Location:</b>	Within the SDP.
<b>Category:</b>	Grounding and Bonding
<b>Equipment:</b>	SDP
<b>Imminent:</b>	Yes
<b>Action:</b>	Mitigated by notifying the O&M; provider of the issue.
<b>Assigned To:</b>	O&M; Provider
<b>Code:</b>	British Standard 542: Earthing arrangements
<b>Status:</b>	Open

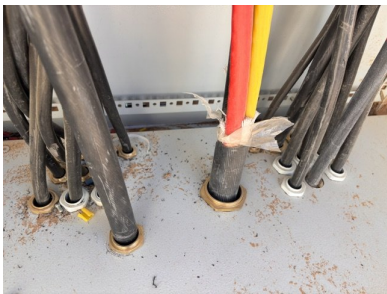
<b>Deficiency #2</b>	<b>RAC 2</b>	<b>Occurrences: 22</b>
----------------------	--------------	------------------------

**Description:** SWA cables are not bonded.

<b>Location:</b>	Within the SDP.
<b>Category:</b>	Grounding and Bonding
<b>Equipment:</b>	SDP
<b>Imminent:</b>	No
<b>Action:</b>	N/A
<b>Assigned To:</b>	O&M; Provider
<b>Code:</b>	British Standard 542: Earthing arrangements
<b>Status:</b>	Open

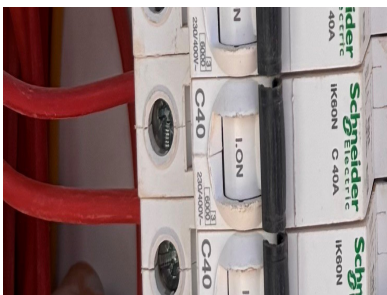
<b>Deficiency #3</b>	<b>RAC 2</b>	<b>Occurrences: 2</b>
----------------------	--------------	-----------------------

**Description:** Oversized breakers feeding conductors. (40A breakers feeding 4mm conductors)

<b>Location:</b>	Within the SDP.
<b>Category:</b>	Improper Use / Damaged
<b>Equipment:</b>	SDP
<b>Imminent:</b>	No
<b>Action:</b>	N/A
<b>Assigned To:</b>	O&M; Provider
<b>Code:</b>	British Standard Appx 4: Current carrying capacities and voltage drop for cables
<b>Status:</b>	Open

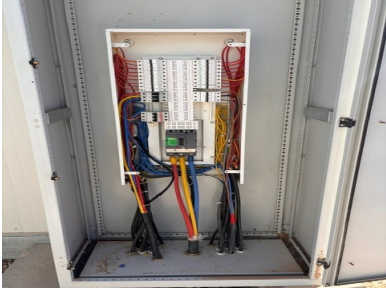
Deficiency #4

**Description:** No dead front within panel.

<b>Location:</b>	Within the SDP.
<b>Category:</b>	Improper Use / Damaged
<b>Equipment:</b>	SDP
<b>Imminent:</b>	No
<b>Action:</b>	N/A
<b>Assigned To:</b>	O&M; Provider
<b>Code:</b>	British Standard 132: Protection against electric shock
<b>Status:</b>	Open
