Task Force SAFE

Inspection-Report_TFSAFE_Full_ALQ26_SDP-3-1-N_113_13-06-26_1-11

Base Location	Al Quwayrah	Date:	13-JUN-2026
Base Code	ALQ26	Team #:	113
Building #	SDP-3-1-N	System Voltage	230/400
Building Type	SDP	Inspection Phase	Full Inspection
Previous Report #:	N/A	Work Order:	TFS-ALQ26-2026-00011

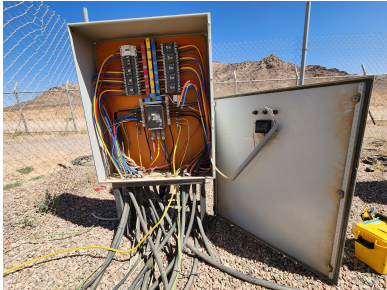
Deficiency #1	RAC 2	Occurrences: 1
----------------------	--------------	-----------------------

Description: SDP-3-1-N is unlisted.

Location:	Located behind gym on the northern perimeter.
Category:	Unlisted Equipment
Equipment:	SDP
Imminent:	No
Action:	N/A
Assigned To:	O&M; Provider
Code:	British Standard 511: Compliance with standards
Status:	Open

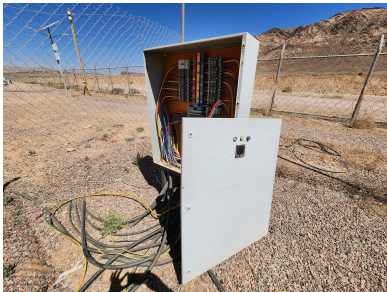
Deficiency #2	RAC 2	Occurrences: 1
----------------------	--------------	-----------------------

Description: Door to SDP is damaged and fixed into position using self-tapping screws.

Location:	SDP.
Category:	Improper Use / Damaged
Equipment:	SDP
Imminent:	No
Action:	N/A
Assigned To:	O&M; Provider
Code:	British Standard 642: Inspection
Status:	Open

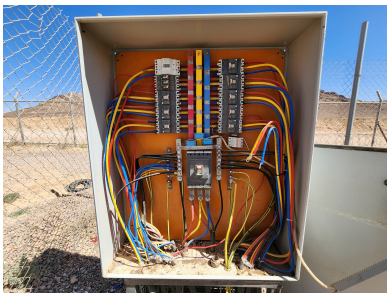
Deficiency #3	RAC 2	Occurrences: 1
----------------------	--------------	-----------------------

Description: No dead front present within SDP.

Location:	Within SDP.
Category:	Improper Use / Damaged
Equipment:	SDP
Imminent:	No
Action:	N/A
Assigned To:	O&M; Provider
Code:	British Standard 132: Protection against electric shock
Status:	Open

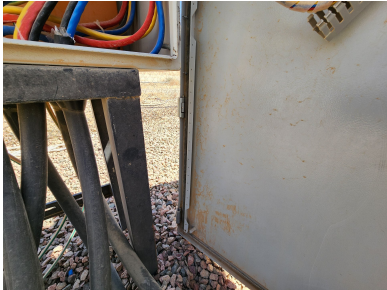
Deficiency #4	RAC 2	Occurrences: 1
----------------------	--------------	-----------------------

Description: No supplementary bond present to door.

Location:	Within SDP.
Category:	Grounding and Bonding
Equipment:	GND
Imminent:	No
Action:	N/A
Assigned To:	O&M; Provider
Code:	British Standard 542: Earthing arrangements
Status:	Open

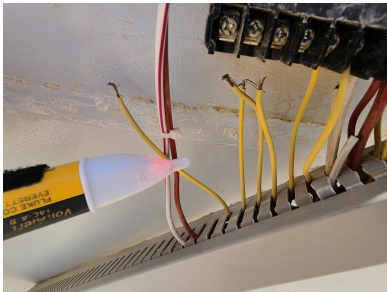
Deficiency #5	RAC 1	Occurrences: 4
----------------------	--------------	-----------------------

Description: Containment to internal wiring is damaged, exposing live conductors.

Location:	Within SDP.
Category:	Improper Use / Damaged
Equipment:	SDP
Imminent:	Yes
Action:	Wiring de-energized and stripped out.
Assigned To:	Task Force SAFE
Code:	British Standard 132: Protection against electric shock
Status:	Closed / Repaired

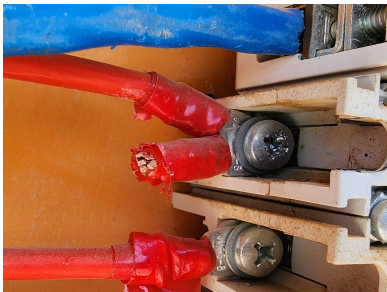
Deficiency #6	RAC 3	Occurrences: 1
----------------------	--------------	-----------------------

Description: Exposed live end where old wiring has not been safely removed.

Location:	Within SDP, circuit 2/L1.
Category:	Poor Workmanship
Equipment:	SDP
Imminent:	No
Action:	N/A
Assigned To:	O&M; Provider
Code:	British Standard 132: Protection against electric shock
Status:	Open

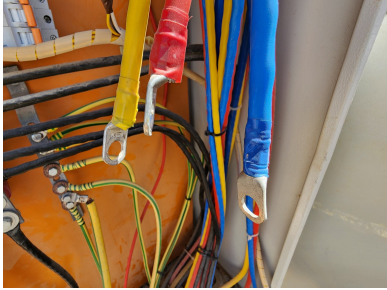
Deficiency #7	RAC 3	Occurrences: 3
----------------------	--------------	-----------------------

Description: Redundant outgoing circuit has bare ends left exposed. TF Safe made safe on the spot.

Location:	Within SDP.
Category:	Poor Workmanship
Equipment:	SDP
Imminent:	No
Action:	N/A
Assigned To:	Task Force SAFE
Code:	British Standard 510: Common rules
Status:	Closed / Repaired

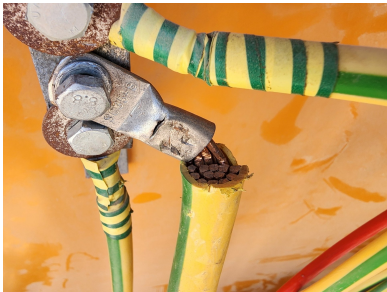
Deficiency #8	RAC 2	Occurrences: 1
----------------------	--------------	-----------------------

Description: Outgoing CPC has strands cut out, reducing cross sectional area.

Location:	Within SDP.
Category:	Grounding and Bonding
Equipment:	GND
Imminent:	No
Action:	N/A
Assigned To:	O&M; Provider
Code:	British Standard 542: Earthing arrangements
Status:	Open

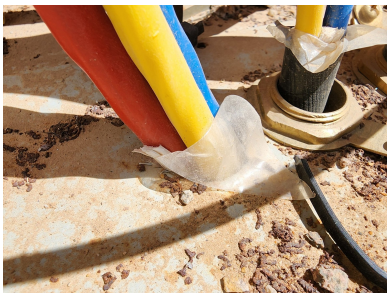
Deficiency #9	RAC 3	Occurrences: 1
----------------------	--------------	-----------------------

Description: No SWA gland present to circuit 1/TP, providing abrasion protection to conductors.

Location:	Within SDP, circuit 1/TP.
Category:	Poor Workmanship
Equipment:	SDP
Imminent:	No
Action:	N/A
Assigned To:	O&M; Provider
Code:	British Standard 510: Common rules
Status:	Open

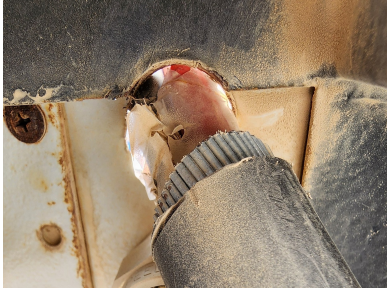
Deficiency #10	RAC 2	Occurrences: 1
-----------------------	--------------	-----------------------

Description: No SWA gland present to circuit 1/TP, providing earthing to steel wire armouring.

Location:	SDP, circuit 1/TP.
Category:	Grounding and Bonding
Equipment:	GND
Imminent:	No
Action:	N/A
Assigned To:	O&M; Provider
Code:	British Standard 542: Earthing arrangements
Status:	Open

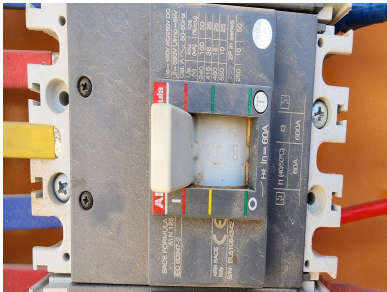
Deficiency #11	RAC 2	Occurrences: 1
-----------------------	--------------	-----------------------

Description: 10mm² conductor fed from 60A MCCB.

Location:	SDP, circuit 9/TP.
Category:	Improper Use / Damaged
Equipment:	SDP
Imminent:	No
Action:	N/A
Assigned To:	O&M; Provider
Code:	British Standard Appx 4: Current carrying capacities and voltage drop for cables
Status:	Open

x 1 SDP. x 2 100A 3P MCCB's. x 7 60A 3P MCCB's. x 3 30A MCCB's. All cabling, terminations and earthing arrangements. Main earth path is by way of steel wire armouring. 9/TP is a 60A 3P MCCB feeding a single-phase outgoing circuit. Ze readings are high but still within the maximum permitted tolerance of 0.8 Ohms.
