## Task Force SAFE

**Inspection-Report\_TFSAFE\_Full\_KFAB22\_Oiltown-Common-RM\_116\_13-06-26\_1-5**

<b>Base Location</b>	KFAB (Jordan)	<b>Date:</b>	13-JUN-2026
<b>Base Code</b>	KFAB22	<b>Team #:</b>	116
<b>Building #</b>	Oiltown-Common-RM	<b>System Voltage</b>	230/400
<b>Building Type</b>	COMMON AREA	<b>Inspection Phase</b>	Full Inspection
<b>Previous Report #:</b>	N/A	<b>Work Order:</b>	TFS-KFAB22-2026-00014

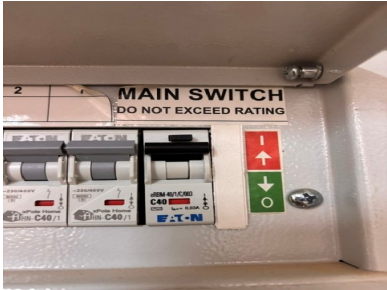
<b>Deficiency #1</b>	<b>RAC 2</b>	<b>Occurrences: 1</b>
----------------------	--------------	-----------------------

**Description:** Type AC RCD used. Type AC RCD is not suitable for this building.

<b>Location:</b>	Within the CDP.
<b>Category:</b>	Improper Use / Damaged
<b>Equipment:</b>	CDP
<b>Imminent:</b>	No
<b>Action:</b>	N/A
<b>Assigned To:</b>	O&M; Provider
<b>Code:</b>	British Standard 132: Protection against electric shock
<b>Status:</b>	Open

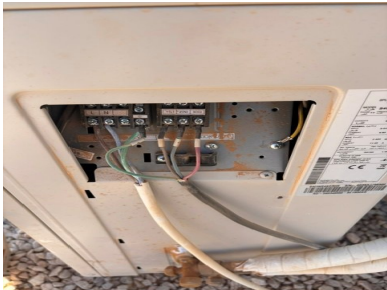
<b>Deficiency #2</b>	<b>RAC 2</b>	<b>Occurrences: 2</b>
----------------------	--------------	-----------------------

**Description:** Cable clips not used: strain on terminations.

<b>Location:</b>	External AC condensers.
<b>Category:</b>	Improper Use / Damaged
<b>Equipment:</b>	WLT
<b>Imminent:</b>	No
<b>Action:</b>	N/A
<b>Assigned To:</b>	O&M; Provider
<b>Code:</b>	British Standard 522: Selection and erection of wiring systems in relation to external influences
<b>Status:</b>	Open

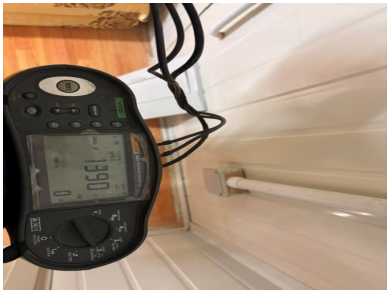
<b>Deficiency #3</b>	<b>RAC 2</b>	<b>Occurrences: 6</b>
----------------------	--------------	-----------------------

**Description:** High Zs reading of 1390 ohms throughout the common room.

<b>Location:</b>	All circuits.
<b>Category:</b>	Grounding and Bonding
<b>Equipment:</b>	WLT
<b>Imminent:</b>	No
<b>Action:</b>	N/A
<b>Assigned To:</b>	O&M; Provider
<b>Code:</b>	British Standard 542: Earthing arrangements
<b>Status:</b>	Open

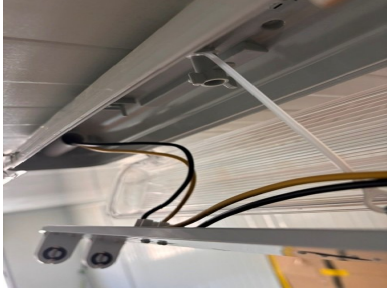
<b>Deficiency #4</b>	<b>RAC 2</b>	<b>Occurrences: 1</b>
----------------------	--------------	-----------------------

**Description:** No CPC to lighting circuit.

<b>Location:</b>	Within lighting circuit including switches.
<b>Category:</b>	Grounding and Bonding
<b>Equipment:</b>	LTG
<b>Imminent:</b>	No
<b>Action:</b>	N/A
<b>Assigned To:</b>	O&M; Provider
<b>Code:</b>	British Standard 542: Earthing arrangements
<b>Status:</b>	Open

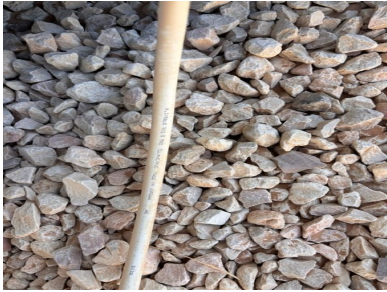
<b>Deficiency #5</b>	<b>RAC 2</b>	<b>Occurrences: 2</b>
----------------------	--------------	-----------------------

**Description:** Unlisted cables.

<b>Location:</b>	At external AC condensers.
<b>Category:</b>	Unlisted Equipment
<b>Equipment:</b>	WLT
<b>Imminent:</b>	No
<b>Action:</b>	N/A
<b>Assigned To:</b>	O&M; Provider
<b>Code:</b>	British Standard 511: Compliance with standards
<b>Status:</b>	Open
