## Task Force SAFE

## Inspection-Report\_TFSAFE\_Full\_ALQ26\_SDP-1-W\_113\_15-06-26\_1-6

<b>Base Location</b>	Al Quwayrah	<b>Date:</b>	15-JUN-2026
<b>Base Code</b>	ALQ26	<b>Team #:</b>	113
<b>Building #</b>	SDP-1-W	<b>System Voltage</b>	230/400
<b>Building Type</b>	SDP	<b>Inspection Phase</b>	Full Inspection
<b>Previous Report #:</b>	N/A	<b>Work Order:</b>	TFS-ALQ26-2026-00012

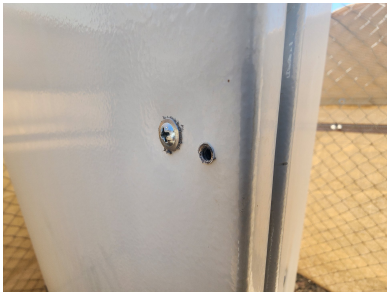
<b>Deficiency #1</b>	<b>RAC 2</b>	<b>Occurrences: 1</b>
----------------------	--------------	-----------------------

**Description:** Locking mechanism to door is damaged. Fixed into position with self-tapping screws. Access requires the use of a tool and SDP-1-W is fenced off.

<b>Location:</b>	SDP-1-W
<b>Category:</b>	Improper Use / Damaged
<b>Equipment:</b>	SDP
<b>Imminent:</b>	No
<b>Action:</b>	N/A
<b>Assigned To:</b>	O&M; Provider
<b>Code:</b>	British Standard 642: Inspection
<b>Status:</b>	Open

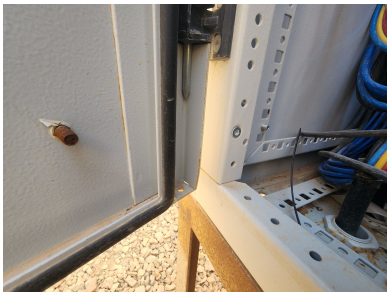
<b>Deficiency #2</b>	<b>RAC 2</b>	<b>Occurrences: 1</b>
----------------------	--------------	-----------------------

**Description:** No supplementary bond present to door.

<b>Location:</b>	Within SDP.
<b>Category:</b>	Grounding and Bonding
<b>Equipment:</b>	GND
<b>Imminent:</b>	No
<b>Action:</b>	N/A
<b>Assigned To:</b>	O&M; Provider
<b>Code:</b>	British Standard 542: Earthing arrangements
<b>Status:</b>	Open

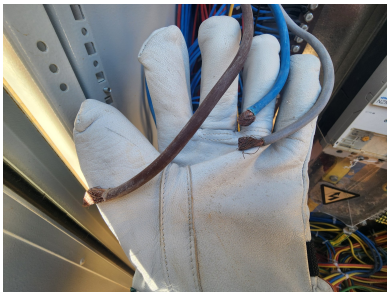
<b>Deficiency #3</b>	<b>RAC 3</b>	<b>Occurrences: 14</b>
----------------------	--------------	------------------------

**Description:** Redundant outgoing circuits have bare ends left exposed.

<b>Location:</b>	Within SDP.
<b>Category:</b>	Poor Workmanship
<b>Equipment:</b>	SDP
<b>Imminent:</b>	No
<b>Action:</b>	N/A
<b>Assigned To:</b>	O&M; Provider
<b>Code:</b>	British Standard 510: Common rules
<b>Status:</b>	Closed / Repaired

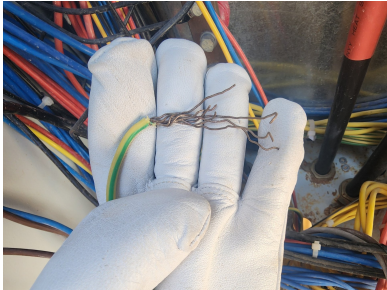
<b>Deficiency #4</b>	<b>RAC 1</b>	<b>Occurrences: 1</b>
----------------------	--------------	-----------------------

**Description:** CPC to circuit 12/TP has become disconnected.

<b>Location:</b>	Within SDP, circuit 12/TP.
<b>Category:</b>	Improper Use / Damaged
<b>Equipment:</b>	GND
<b>Imminent:</b>	Yes
<b>Action:</b>	N/A
<b>Assigned To:</b>	O&M; Provider
<b>Code:</b>	British Standard 542: Earthing arrangements
<b>Status:</b>	Closed / Repaired

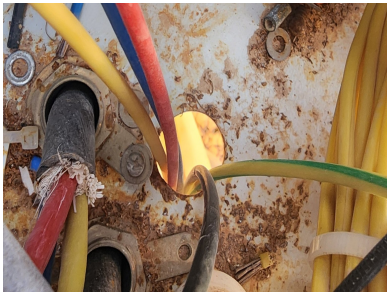
<b>Deficiency #5</b>	<b>RAC 3</b>	<b>Occurrences: 1</b>
----------------------	--------------	-----------------------

**Description:** No SWA gland in place to circuit 12/TP, providing abrasion protection.

<b>Location:</b>	Within SDP, circuit 12/TP.
<b>Category:</b>	Poor Workmanship
<b>Equipment:</b>	SDP
<b>Imminent:</b>	No
<b>Action:</b>	N/A
<b>Assigned To:</b>	O&M; Provider
<b>Code:</b>	British Standard 510: Common rules
<b>Status:</b>	Open

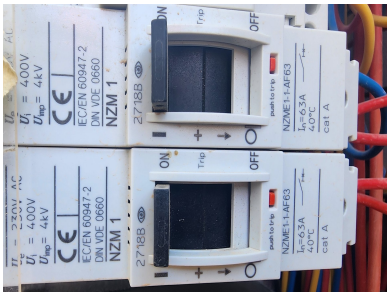
<b>Deficiency #6</b>	<b>RAC 2</b>	<b>Occurrences: 3</b>
----------------------	--------------	-----------------------

**Description:** Circuit 7/L2 - 10mm<sup>2</sup> three-core SWA fed from 63A 1P MCCB. Circuit 24/L1 and 24/L2 - 6mm<sup>2</sup> three-core SWA's fed from 63A 1P MCCB's.

<b>Location:</b>	Within SDP, circuit 7/L2, 24/L1 and 24/L2.
<b>Category:</b>	Improper Use / Damaged
<b>Equipment:</b>	SDP
<b>Imminent:</b>	No
<b>Action:</b>	N/A
<b>Assigned To:</b>	O&M; Provider
<b>Code:</b>	British Standard Appx 4: Current carrying capacities and voltage drop for cables
<b>Status:</b>	Open
