## Task Force SAFE

**Inspection-Report\_TFSAFE\_Full\_KATAB\_29100-Warehouse-EXT\_128\_16-06-26\_1-4**

<b>Base Location</b>	KA2AB (Jordan)	<b>Date:</b>	16-JUN-2026
<b>Base Code</b>	KATAB	<b>Team #:</b>	128
<b>Building #</b>	29100-Warehouse-EXT	<b>System Voltage</b>	230/400
<b>Building Type</b>	OTHER	<b>Inspection Phase</b>	Full Inspection
<b>Previous Report #:</b>	N/A	<b>Work Order:</b>	TFS-KATAB-2026-00004

Camp Xiphos warehouse is located within the expansion area next to the fuel pad within Camp Xiphos.

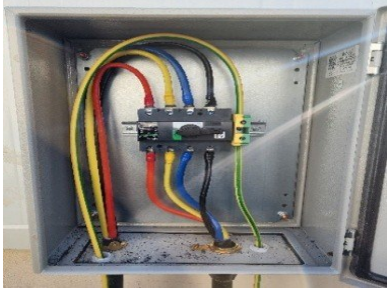
<b>Deficiency #1</b>	<b>RAC 2</b>	<b>Occurrences: 1</b>
----------------------	--------------	-----------------------

**Description:** Enclosure has not been bonded.

<b>Location:</b>	Within enclosure for isolator supplying air handling unit, south western corner.
<b>Category:</b>	Grounding and Bonding
<b>Equipment:</b>	WLT
<b>Imminent:</b>	No
<b>Action:</b>	N/A
<b>Assigned To:</b>	O&M; Provider
<b>Code:</b>	British Standard 542: Earthing arrangements
<b>Status:</b>	Closed / Repaired

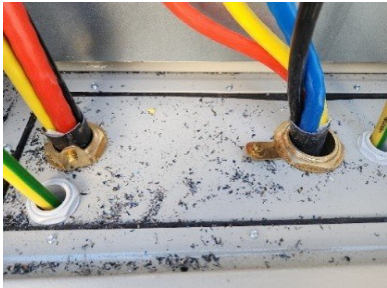
<b>Deficiency #2</b>	<b>RAC 2</b>	<b>Occurrences: 3</b>
----------------------	--------------	-----------------------

**Description:** No bonding from earth tags to enclosure as glanding plate is insulated, preventing earth path.

<b>Location:</b>	Within enclosure for isolator supplying air handling unit, south western corner.
<b>Category:</b>	Grounding and Bonding
<b>Equipment:</b>	WLT
<b>Imminent:</b>	No
<b>Action:</b>	N/A
<b>Assigned To:</b>	O&M; Provider
<b>Code:</b>	British Standard 542: Earthing arrangements
<b>Status:</b>	Closed / Repaired

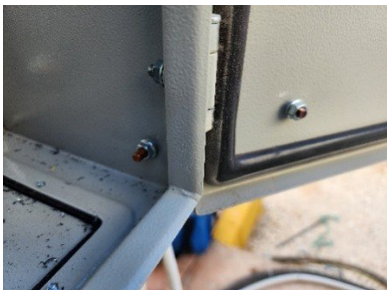
<b>Deficiency #3</b>	<b>RAC 2</b>	<b>Occurrences: 1</b>
----------------------	--------------	-----------------------

**Description:** Door has not been bonded.

<b>Location:</b>	Enclosure door.
<b>Category:</b>	Grounding and Bonding
<b>Equipment:</b>	WLT
<b>Imminent:</b>	No
<b>Action:</b>	N/A
<b>Assigned To:</b>	O&M; Provider
<b>Code:</b>	British Standard 542: Earthing arrangements
<b>Status:</b>	Closed / Repaired

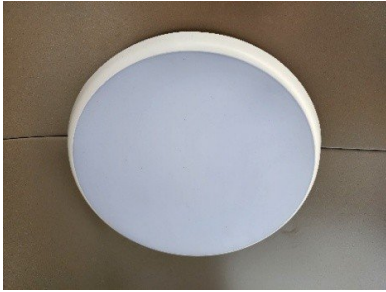
**Deficiency #4****RAC 2****Occurrences: 3****Description:** Light fixtures are unlisted. Data sheet required.

<b>Location:</b>	External lighting, above all three entrances.
<b>Category:</b>	Unlisted Equipment
<b>Equipment:</b>	WLT
<b>Imminent:</b>	No
<b>Action:</b>	N/A
<b>Assigned To:</b>	O&M; Provider
<b>Code:</b>	British Standard 511: Compliance with standards
<b>Status:</b>	Closed / Repaired
