Task Force SAFE

Inspection-Report_TFSAFE_Full_KFAB22_Oiltown-Fire-CHU_116_16-06-26_1-8

Base Location	KFAB (Jordan)	Date:	16-JUN-2026
Base Code	KFAB22	Team #:	116
Building #	Oiltown-Fire-CHU	System Voltage	230/400
Building Type	ACCOMM	Inspection Phase	Full Inspection
Previous Report #:	N/A	Work Order:	TFS-KFAB22-2026-00016

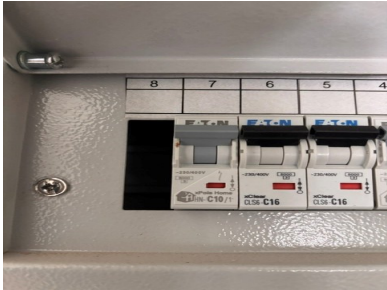
Deficiency #1	RAC 2	Occurrences: 1
----------------------	--------------	-----------------------

Description: Breaker blank missing from dead front.

Location:	At CDP.
Category:	Improper Use / Damaged
Equipment:	CDP
Imminent:	No
Action:	N/A
Assigned To:	O&M; Provider
Code:	British Standard 132: Protection against electric shock
Status:	Open

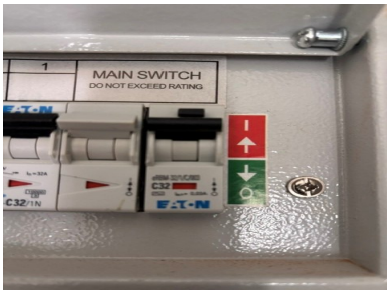
Deficiency #2	RAC 2	Occurrences: 1
----------------------	--------------	-----------------------

Description: Type AC RCD used. Type AC RCD is not suitable for this building.

Location:	Within the CDP.
Category:	Improper Use / Damaged
Equipment:	CDP
Imminent:	No
Action:	N/A
Assigned To:	O&M; Provider
Code:	British Standard 132: Protection against electric shock
Status:	Open

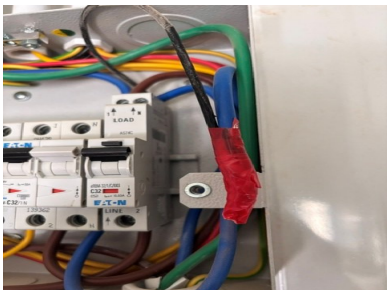
Deficiency #3	RAC 2	Occurrences: 1
----------------------	--------------	-----------------------

Description: Twist taped connection made to main neutral.

Location:	Within the CDP.
Category:	Improper Terminations
Equipment:	CDP
Imminent:	No
Action:	N/A
Assigned To:	O&M; Provider
Code:	British Standard 526: Electrical connections
Status:	Open

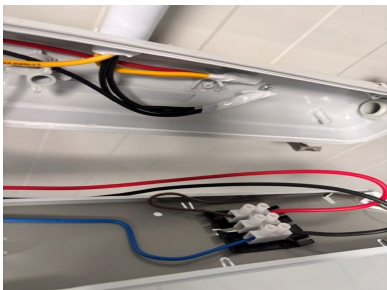
Deficiency #4	RAC 2	Occurrences: 1
----------------------	--------------	-----------------------

Description: No CPC to lighting circuit.

Location:	Within lighting circuit including switches.
Category:	Grounding and Bonding
Equipment:	WLT
Imminent:	No
Action:	N/A
Assigned To:	O&M; Provider
Code:	British Standard 542: Earthing arrangements
Status:	Open

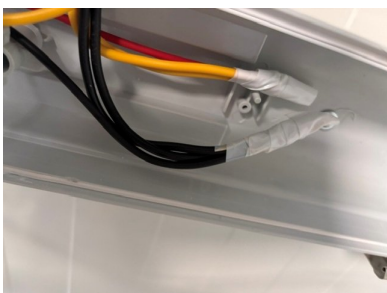
Deficiency #5	RAC 2	Occurrences: 6
----------------------	--------------	-----------------------

Description: Twist taped connections made to live and neutral.

Location:	Internal light fittings.
Category:	Improper Terminations
Equipment:	WLT
Imminent:	No
Action:	N/A
Assigned To:	O&M; Provider
Code:	British Standard 526: Electrical connections
Status:	Open

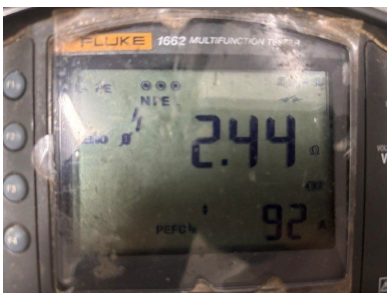
Deficiency #6	RAC 2	Occurrences: 6
----------------------	--------------	-----------------------

Description: High Zs reading of 2.44 ohms throughout the CHU.

Location:	All circuits.
Category:	Grounding and Bonding
Equipment:	WLT
Imminent:	No
Action:	N/A
Assigned To:	O&M; Provider
Code:	British Standard 542: Earthing arrangements
Status:	Open

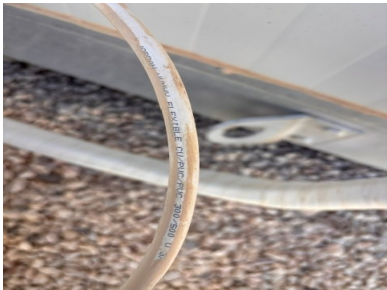
Deficiency #7	RAC 2	Occurrences: 3
----------------------	--------------	-----------------------

Description: Unlisted cables.

Location:	At external AC condensers.
Category:	Unlisted Equipment
Equipment:	WLT
Imminent:	No
Action:	N/A
Assigned To:	O&M; Provider
Code:	British Standard 511: Compliance with standards
Status:	Open

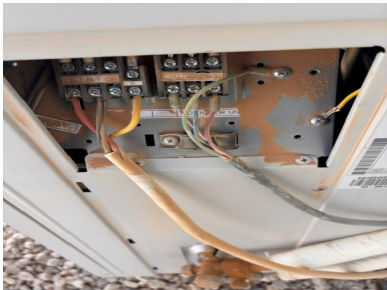
Deficiency #8	RAC 2	Occurrences: 3
----------------------	--------------	-----------------------

Description: Cable clips not used: strain on terminations.

Location:	At external AC condensers.
Category:	Improper Use / Damaged
Equipment:	WLT
Imminent:	No
Action:	N/A
Assigned To:	O&M; Provider
Code:	British Standard 522: Selection and erection of wiring systems in relation to external influences
Status:	Open
