Task Force SAFE

Inspection-Report_TFSAFE_Full_7NX32_Hangar-RM-2_128_17-06-26_1-3

Base Location	H-5 (Jordan)	Date:	17-JUN-2026
Base Code	7NX32	Team #:	128
Building #	Hangar-RM-2	System Voltage	230/400
Building Type	HANGAR	Inspection Phase	Full Inspection
Previous Report #:	N/A	Work Order:	TFS-7NX32-2026-00004

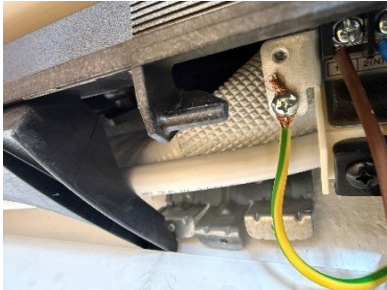
Deficiency #1	RAC 2	Occurrences: 2
----------------------	--------------	-----------------------

Description: CPC is poorly terminated.

Location:	AC units, back wall.
Category:	Improper Terminations
Equipment:	WLT
Imminent:	No
Action:	N/A
Assigned To:	O&M; Provider
Code:	British Standard 526: Electrical connections
Status:	Closed / Repaired

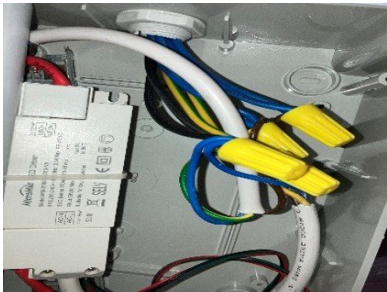
Deficiency #2	RAC 2	Occurrences: 9
----------------------	--------------	-----------------------

Description: LED drivers are unlisted. Data sheet required.

Location:	LED drivers at light fixtures.
Category:	Unlisted Equipment
Equipment:	WLT
Imminent:	No
Action:	N/A
Assigned To:	O&M; Provider
Code:	British Standard 511: Compliance with standards
Status:	Open

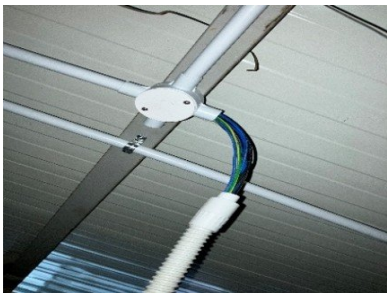
Deficiency #3	RAC 2	Occurrences: 9
----------------------	--------------	-----------------------

Description: Exposed single insulated cables above the ceiling.

Location:	Cables above the ceiling at the light fixtures.
Category:	Improper Use / Damaged
Equipment:	WLT
Imminent:	No
Action:	N/A
Assigned To:	O&M; Provider
Code:	British Standard 522: Selection and erection of wiring systems in relation to external influences
Status:	Closed / Repaired
