Task Force SAFE

Inspection-Report_TFSAFE_Full_KFAB22_Oiltown-Safety_116_17-06-26_1-6

Base Location	KFAB (Jordan)	Date:	17-JUN-2026
Base Code	KFAB22	Team #:	116
Building #	Oiltown-Safety	System Voltage	230/400
Building Type	OFFICE	Inspection Phase	Full Inspection
Previous Report #:	N/A	Work Order:	TFS-KFAB22-2026-00017

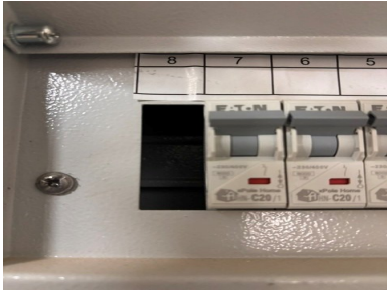
Deficiency #1	RAC 2	Occurrences: 1
----------------------	--------------	-----------------------

Description: Breaker blank missing from dead front.

Location:	At CDP.
Category:	Improper Use / Damaged
Equipment:	CDP
Imminent:	No
Action:	N/A
Assigned To:	O&M; Provider
Code:	British Standard 132: Protection against electric shock
Status:	Open

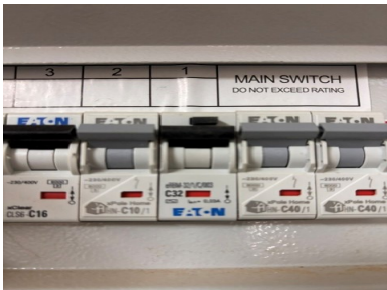
Deficiency #2	RAC 2	Occurrences: 1
----------------------	--------------	-----------------------

Description: Type AC RCD used. Type AC RCD is not suitable for this building.

Location:	Within the CDP.
Category:	Improper Use / Damaged
Equipment:	CDP
Imminent:	No
Action:	N/A
Assigned To:	O&M; Provider
Code:	British Standard 132: Protection against electric shock
Status:	Open

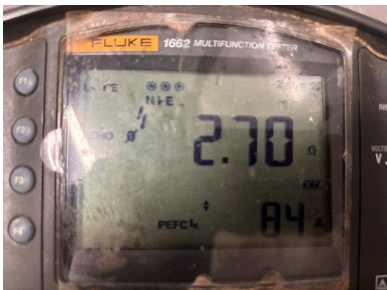
Deficiency #3	RAC 2	Occurrences: 6
----------------------	--------------	-----------------------

Description: High Zs reading of 2.7 ohms throughout the building.

Location:	All circuits.
Category:	Grounding and Bonding
Equipment:	WLT
Imminent:	No
Action:	N/A
Assigned To:	O&M; Provider
Code:	British Standard 542: Earthing arrangements
Status:	Open

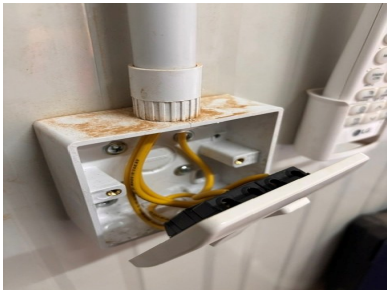
Deficiency #4	RAC 2	Occurrences: 3
----------------------	--------------	-----------------------

Description: No CPC to light switches.

Location:	At light switches.
Category:	Grounding and Bonding
Equipment:	WLT
Imminent:	No
Action:	N/A
Assigned To:	O&M; Provider
Code:	British Standard 542: Earthing arrangements
Status:	Open

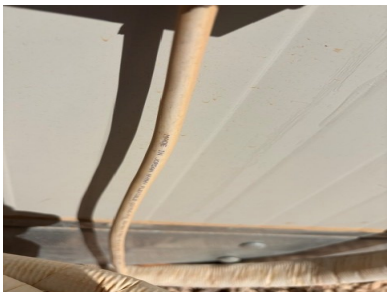
Deficiency #5	RAC 2	Occurrences: 3
----------------------	--------------	-----------------------

Description: Unlisted cables.

Location:	At external AC condensers.
Category:	Unlisted Equipment
Equipment:	WLT
Imminent:	No
Action:	N/A
Assigned To:	O&M; Provider
Code:	British Standard 511: Compliance with standards
Status:	Open

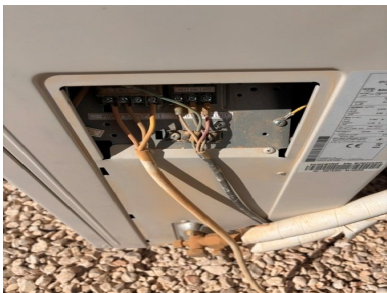
Deficiency #6	RAC 2	Occurrences: 3
----------------------	--------------	-----------------------

Description: Cable clips not used: strain on terminations.

Location:	At external AC condensers.
Category:	Improper Use / Damaged
Equipment:	WLT
Imminent:	No
Action:	N/A
Assigned To:	O&M; Provider
Code:	British Standard 522: Selection and erection of wiring systems in relation to external influences
Status:	Open
