Task Force SAFE

Inspection-Report_TFSAFE_Full_KFAB22_Oiltown-LSAU-Male_116_02-06-26_1-9

Base Location	KFAB (Jordan)	Date:	02-JUN-2026
Base Code	KFAB22	Team #:	116
Building #	Oiltown-LSAU-Male	System Voltage	230/400
Building Type	LSAU	Inspection Phase	Full Inspection
Previous Report #:	N/A	Work Order:	TFS-KFAB22-2026-00002

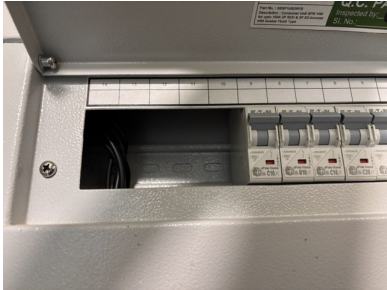
Deficiency #1	RAC 2	Occurrences: 5
----------------------	--------------	-----------------------

Description: Breaker blanks missing from dead front.

Location:	At CDP.
Category:	Improper Use / Damaged
Equipment:	CDP
Imminent:	No
Action:	N/A
Assigned To:	O&M; Provider
Code:	British Standard 132: Protection against electric shock
Status:	Open

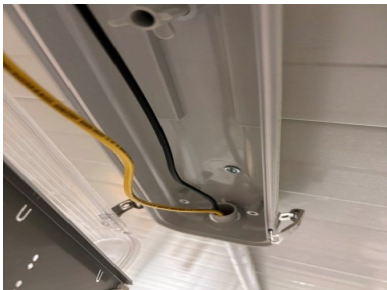
Deficiency #2	RAC 2	Occurrences: 1
----------------------	--------------	-----------------------

Description: No CPC to lighting circuit.

Location:	Within lighting circuit including switches.
Category:	Grounding and Bonding
Equipment:	LTG
Imminent:	No
Action:	N/A
Assigned To:	O&M; Provider
Code:	British Standard 542: Earthing arrangements
Status:	Open

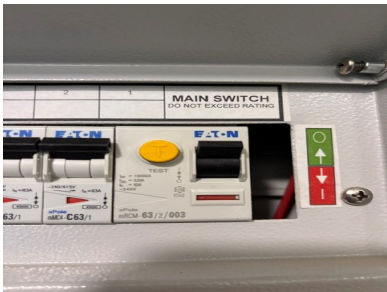
Deficiency #3	RAC 2	Occurrences: 1
----------------------	--------------	-----------------------

Description: Type AC RCD used. Type AC RCD is not suitable for this building.

Location:	Within CDP.
Category:	Improper Use / Damaged
Equipment:	CDP
Imminent:	No
Action:	N/A
Assigned To:	O&M; Provider
Code:	British Standard 132: Protection against electric shock
Status:	Open

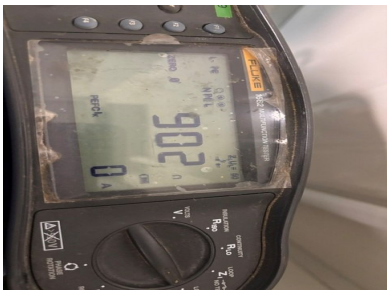
Deficiency #4	RAC 2	Occurrences: 6
----------------------	--------------	-----------------------

Description: High Zs reading of 902 ohms throughout the LSAU.

Location:	All circuits.
Category:	Grounding and Bonding
Equipment:	WLT
Imminent:	No
Action:	N/A
Assigned To:	O&M; Provider
Code:	British Standard 542: Earthing arrangements
Status:	Open

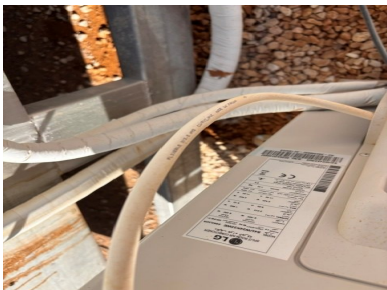
Deficiency #5	RAC 2	Occurrences: 2
----------------------	--------------	-----------------------

Description: Unlisted cables.

Location:	Within external A/C condenser supply cables.
Category:	Unlisted Equipment
Equipment:	WLT
Imminent:	No
Action:	N/A
Assigned To:	O&M; Provider
Code:	British Standard 511: Compliance with standards
Status:	Open

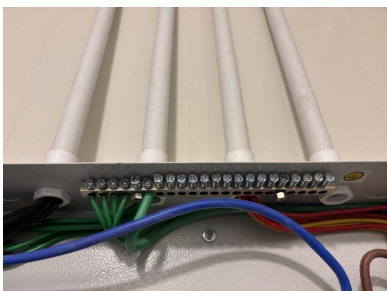
Deficiency #6	RAC 2	Occurrences: 3
----------------------	--------------	-----------------------

Description: Earth, live and neutral wires installed in separate conduits.

Location:	Within the CDP.
Category:	Improper Use / Damaged
Equipment:	CDP
Imminent:	No
Action:	N/A
Assigned To:	O&M; Provider
Code:	British Standard 642: Inspection
Status:	Open

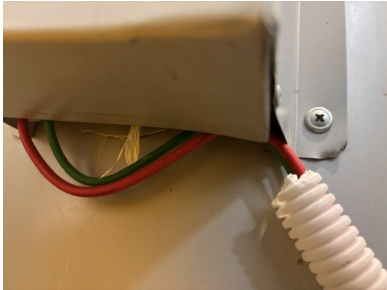
Deficiency #7	RAC 2	Occurrences: 3
----------------------	--------------	-----------------------

Description: Exposed single insulated conductors. Flexible plastic conduit too short to secure to water heater.

Location:	Supply cables feeding water heater.
Category:	Improper Use / Damaged
Equipment:	WLT
Imminent:	No
Action:	N/A
Assigned To:	O&M; Provider
Code:	British Standard 642: Inspection
Status:	Open

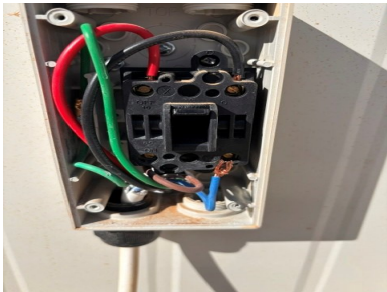
Deficiency #8	RAC 2	Occurrences: 1
----------------------	--------------	-----------------------

Description: Loose termination to the load side neutral. TF SAFE repaired on the spot.

Location:	External AC condenser #2
Category:	Improper Terminations
Equipment:	WLT
Imminent:	No
Action:	N/A
Assigned To:	Task Force SAFE
Code:	British Standard 526: Electrical connections
Status:	Closed / Repaired

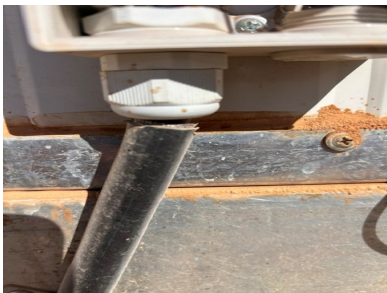
Deficiency #9	RAC 2	Occurrences: 1
----------------------	--------------	-----------------------

Description: SWA cable not bonded to earth.

Location:	External of building, main isolator.
Category:	Grounding and Bonding
Equipment:	WLT
Imminent:	No
Action:	N/A
Assigned To:	O&M; Provider
Code:	British Standard 542: Earthing arrangements
Status:	Open
