Task Force SAFE

Inspection-Report_TFSAFE_Full_KFAB22_Oiltown-EC-130-OPS-2_116_18-06-26_1-

Base Location	KFAB (Jordan)	Date:	18-JUN-2026
Base Code	KFAB22	Team #:	116
Building #	Oiltown-EC-130-OPS-2	System Voltage	230/400
Building Type	OFFICE	Inspection Phase	Full Inspection
Previous Report #:	N/A	Work Order:	TFS-KFAB22-2026-00018

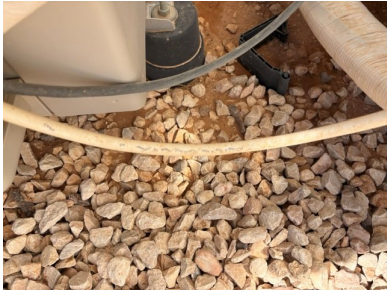
Deficiency #4	RAC 2	Occurrences: 3
----------------------	--------------	-----------------------

Description: Unlisted cables.

Location:	At external AC condensers.
Category:	Unlisted Equipment
Equipment:	WLT
Imminent:	No
Action:	N/A
Assigned To:	O&M; Provider
Code:	British Standard 511: Compliance with standards
Status:	Open

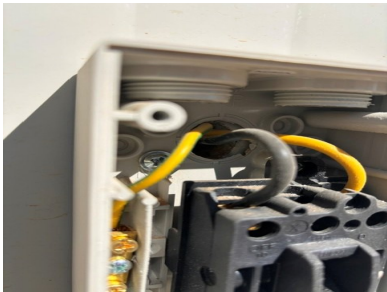
Deficiency #5	RAC 2	Occurrences: 3
----------------------	--------------	-----------------------

Description: No mechanical protection for singles passing through the metal wall.

Location:	At external AC condensers isolators.
Category:	Improper Use / Damaged
Equipment:	WLT
Imminent:	No
Action:	N/A
Assigned To:	O&M; Provider
Code:	British Standard 522: Selection and erection of wiring systems in relation to external influences
Status:	Open

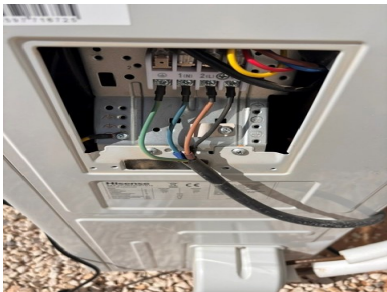
Deficiency #6	RAC 2	Occurrences: 3
----------------------	--------------	-----------------------

Description: Cable clips not used: strain on terminations.

Location:	At external AC condensers.
Category:	Improper Use / Damaged
Equipment:	WLT
Imminent:	No
Action:	N/A
Assigned To:	O&M; Provider
Code:	British Standard 522: Selection and erection of wiring systems in relation to external influences
Status:	Open
