Task Force SAFE

Inspection-Report_TFSAFE_Full_ALQ26_SDP-2-W_113_18-06-26_1-8

Base Location	Al Quwayrah	Date:	18-JUN-2026
Base Code	ALQ26	Team #:	113
Building #	SDP-2-W	System Voltage	230/400
Building Type	SDP	Inspection Phase	Full Inspection
Previous Report #:	N/A	Work Order:	TFS-ALQ26-2026-00015

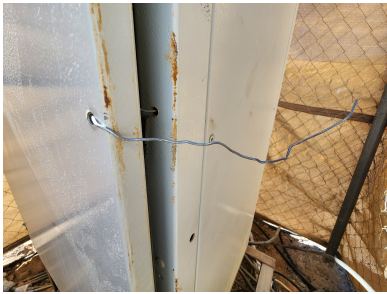
Deficiency #1	RAC 2	Occurrences: 1
----------------------	--------------	-----------------------

Description: Locking mechanism to door is damaged and secured with wire and self-tapping screws. Access requires the use of a tool. SDP-2-W is fenced off and access restricted.

Location:	SDP-2-W
Category:	Improper Use / Damaged
Equipment:	SDP
Imminent:	No
Action:	N/A
Assigned To:	O&M; Provider
Code:	British Standard 642: Inspection
Status:	Open

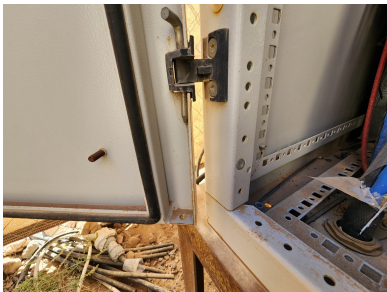
Deficiency #2	RAC 2	Occurrences: 1
----------------------	--------------	-----------------------

Description: No supplementary bond present to door.

Location:	Within SDP.
Category:	Grounding and Bonding
Equipment:	GND
Imminent:	No
Action:	N/A
Assigned To:	O&M; Provider
Code:	British Standard 542: Earthing arrangements
Status:	Open

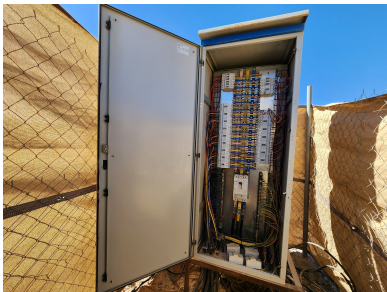
Deficiency #3	RAC 2	Occurrences: 1
----------------------	--------------	-----------------------

Description: No dead front present within SDP. Access requires the use of a tool. SDP-2-W is fenced off and access restricted.

Location:	Within SDP.
Category:	Improper Use / Damaged
Equipment:	SDP
Imminent:	No
Action:	N/A
Assigned To:	O&M; Provider
Code:	British Standard 132: Protection against electric shock
Status:	Open

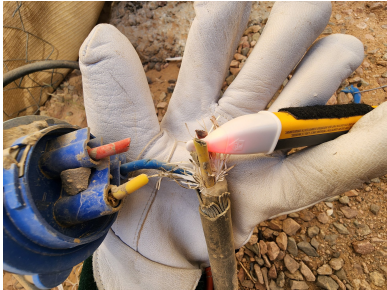
Deficiency #4	RAC 1	Occurrences: 2
----------------------	--------------	-----------------------

Description: Exposed live ends to redundant outgoing circuits.

Location:	Within SDP enclosure, circuit 15/L2 and 15/L3.
Category:	Poor Workmanship
Equipment:	SDP
Imminent:	Yes
Action:	TF Safe isolated circuits and made safe on the spot.
Assigned To:	Task Force SAFE
Code:	British Standard 132: Protection against electric shock
Status:	Closed / Repaired

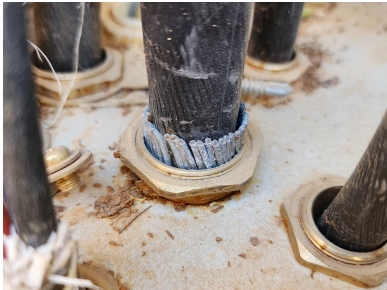
Deficiency #5	RAC 2	Occurrences: 1
----------------------	--------------	-----------------------

Description: SWA gland to circuit 7/TP has been incorrectly fitted. Earth path is relying solely on the steel wire armouring.

Location:	Within SDP, circuit 7/TP.
Category:	Grounding and Bonding
Equipment:	GND
Imminent:	No
Action:	N/A
Assigned To:	O&M; Provider
Code:	British Standard 542: Earthing arrangements
Status:	Open

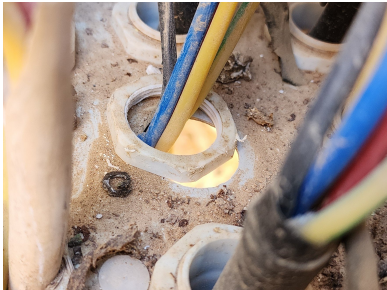
Deficiency #6	RAC 2	Occurrences: 1
----------------------	--------------	-----------------------

Description: Gland to outgoing circuit is damaged, removing abrasion protection to single insulated 3-phase conductors.

Location:	Within SDP.
Category:	Improper Use / Damaged
Equipment:	SDP
Imminent:	No
Action:	N/A
Assigned To:	O&M; Provider
Code:	British Standard 510: Common rules
Status:	Open

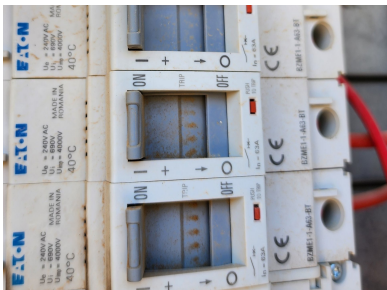
Deficiency #7	RAC 2	Occurrences: 1
----------------------	--------------	-----------------------

Description: Circuit 15/L1 - 6mm2 conductors fed from 63A MCCB.

Location:	Within SDP, circuit 15/L1.
Category:	Improper Use / Damaged
Equipment:	SDP
Imminent:	No
Action:	N/A
Assigned To:	O&M; Provider
Code:	British Standard Appx 4: Current carrying capacities and voltage drop for cables
Status:	Open

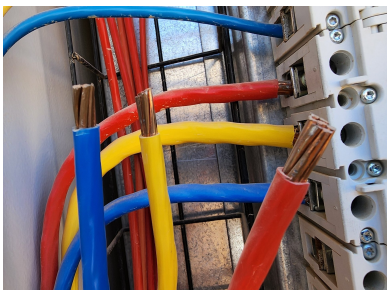
Deficiency #8	RAC 3	Occurrences: 15
----------------------	--------------	------------------------

Description: Redundant outgoing circuits have bare ends left exposed.

Location:	Within SDP, circuit 8/TP, 11/TP, 14/TP, 17/TP and 18/TP.
Category:	Poor Workmanship
Equipment:	SDP
Imminent:	No
Action:	N/A
Assigned To:	O&M; Provider
Code:	British Standard 510: Common rules
Status:	Closed / Repaired
