Task Force SAFE

Inspection-Report_TFSAFE_Full_7NX32_Hangar-RM-4_128_19-06-26_1-2

Base Location	H-5 (Jordan)	Date:	19-JUN-2026
Base Code	7NX32	Team #:	128
Building #	Hangar-RM-4	System Voltage	230/400
Building Type	HANGAR	Inspection Phase	Full Inspection
Previous Report #:	N/A	Work Order:	TFS-7NX32-2026-00012

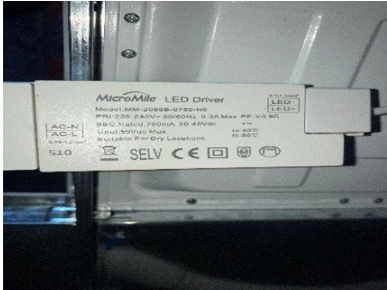
Deficiency #1	RAC 2	Occurrences: 11
----------------------	--------------	------------------------

Description: LED drivers are unlisted. Data sheet required.

Location:	LED drivers at light fixtures.
Category:	Unlisted Equipment
Equipment:	LTG
Imminent:	No
Action:	N/A
Assigned To:	O&M; Provider
Code:	British Standard 511: Compliance with standards
Status:	Open

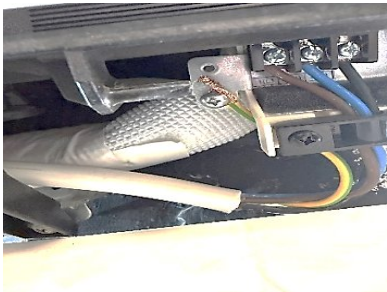
Deficiency #2	RAC 2	Occurrences: 2
----------------------	--------------	-----------------------

Description: CPC is poorly terminated.

Location:	Within AC units, back wall.
Category:	Improper Terminations
Equipment:	WLT
Imminent:	No
Action:	N/A
Assigned To:	O&M; Provider
Code:	British Standard 526: Electrical connections
Status:	Closed / Repaired
