## Task Force SAFE

# Inspection-Report\_TFSAFE\_Full\_ALQ26\_ATS-N\_113\_03-06-26\_1

<b>Base Location</b>	Al Quwayrah	<b>Date:</b>	03-JUN-2026
<b>Base Code</b>	ALQ26	<b>Team #:</b>	113
<b>Building #</b>	ATS-N	<b>System Voltage</b>	230/400
<b>Building Type</b>	ATS	<b>Inspection Phase</b>	Full Inspection
<b>Previous Report #:</b>	N/A	<b>Work Order:</b>	TFS-ALQ26-2026-00002

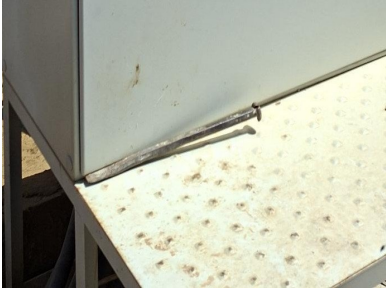
Deficiency #1

RAC 2

**Description:** A crowbar has been wedged against the door to keep it closed as the door locking mechanism is damaged.

<b>Location:</b>	ATS door
<b>Category:</b>	Improper Use / Damaged
<b>Equipment:</b>	ATS
<b>Imminent:</b>	No
<b>Action:</b>	N/A
<b>Assigned To:</b>	O&M; Provider
<b>Code:</b>	British Standard 642: Inspection
<b>Status:</b>	Open
