Task Force SAFE

Inspection-Report_TFSAFE_Full_KFAB22_Oiltown-LSAU-Female_116_03-06-26_1-6

Base Location	KFAB (Jordan)	Date:	03-JUN-2026
Base Code	KFAB22	Team #:	116
Building #	Oiltown-LSAU-Female	System Voltage	230/400
Building Type	LSAU	Inspection Phase	Full Inspection
Previous Report #:	N/A	Work Order:	TFS-KFAB22-2026-00003

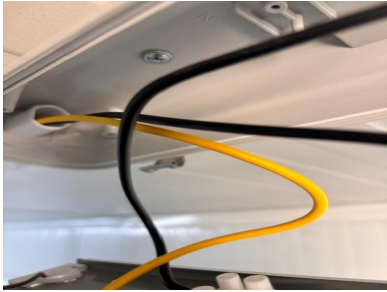
Deficiency #1	RAC 2	Occurrences: 1
----------------------	--------------	-----------------------

Description: No CPC to lighting circuit.

Location:	Within lighting circuit including switches.
Category:	Grounding and Bonding
Equipment:	LTG
Imminent:	No
Action:	N/A
Assigned To:	O&M; Provider
Code:	British Standard 542: Earthing arrangements
Status:	Open

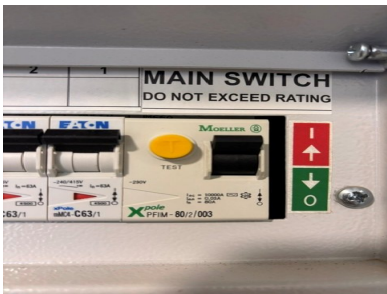
Deficiency #2	RAC 2	Occurrences: 1
----------------------	--------------	-----------------------

Description: Type AC RCD used. Type AC RCD is not suitable for this building.

Location:	Within the CDP.
Category:	Improper Use / Damaged
Equipment:	CDP
Imminent:	No
Action:	N/A
Assigned To:	O&M; Provider
Code:	British Standard 132: Protection against electric shock
Status:	Open

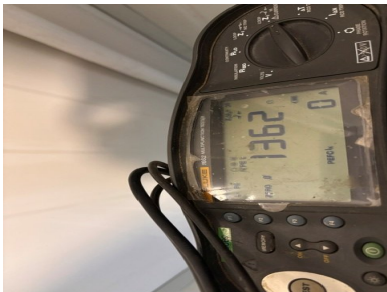
Deficiency #3	RAC 2	Occurrences: 6
----------------------	--------------	-----------------------

Description: High Zs reading of 1362 ohms throughout the LSAU.

Location:	All circuits.
Category:	Grounding and Bonding
Equipment:	WLT
Imminent:	No
Action:	N/A
Assigned To:	O&M; Provider
Code:	British Standard 542: Earthing arrangements
Status:	Open

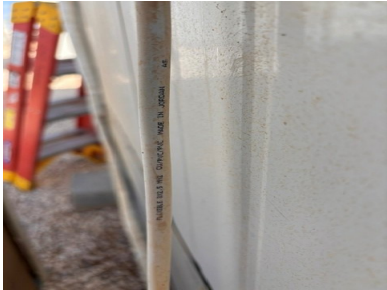
Deficiency #4	RAC 2	Occurrences: 2
----------------------	--------------	-----------------------

Description: Unlisted cables.

Location:	Within external A/C condenser supply cables.
Category:	Unlisted Equipment
Equipment:	WLT
Imminent:	No
Action:	N/A
Assigned To:	O&M; Provider
Code:	British Standard 511: Compliance with standards
Status:	Open

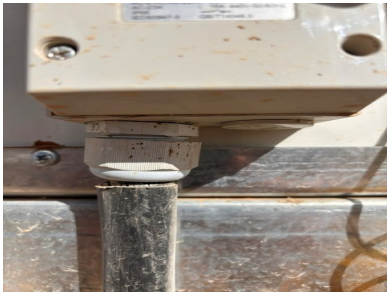
Deficiency #5	RAC 2	Occurrences: 1
----------------------	--------------	-----------------------

Description: SWA cable not bonded to earth.

Location:	External of building, main isolator.
Category:	Grounding and Bonding
Equipment:	WLT
Imminent:	No
Action:	N/A
Assigned To:	O&M; Provider
Code:	British Standard 542: Earthing arrangements
Status:	Open

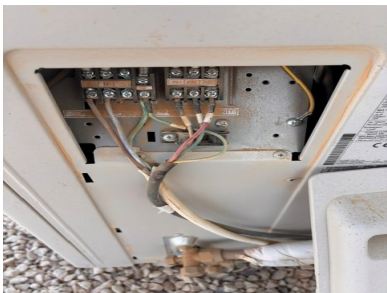
Deficiency #6	RAC 2	Occurrences: 2
----------------------	--------------	-----------------------

Description: Cable clips not used: strain on terminations.

Location:	Within external AC condensers.
Category:	Improper Use / Damaged
Equipment:	WLT
Imminent:	No
Action:	N/A
Assigned To:	O&M; Provider
Code:	British Standard 522: Selection and erection of wiring systems in relation to external influences
Status:	Open
