## Task Force SAFE

## Inspection-Report\_TFSAFE\_Full\_ALQ26\_MDP-N\_113\_04-06-26\_1-2

<b>Base Location</b>	Al Quwayrah	<b>Date:</b>	04-JUN-2026
<b>Base Code</b>	ALQ26	<b>Team #:</b>	113
<b>Building #</b>	MDP-N	<b>System Voltage</b>	230/400
<b>Building Type</b>	MDP	<b>Inspection Phase</b>	Full Inspection
<b>Previous Report #:</b>	N/A	<b>Work Order:</b>	TFS-ALQ26-2026-00003

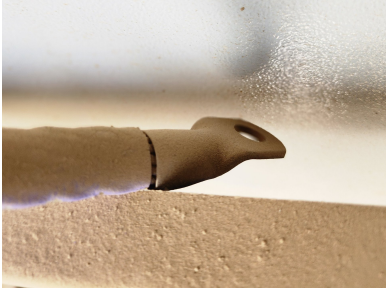
<b>Deficiency #1</b>	<b>RAC 2</b>	<b>Occurrences: 1</b>
----------------------	--------------	-----------------------

**Description:** Neutral earth link is not terminated to the MET.

<b>Location:</b>	Within MDP.
<b>Category:</b>	Grounding and Bonding
<b>Equipment:</b>	MDP
<b>Imminent:</b>	No
<b>Action:</b>	N/A
<b>Assigned To:</b>	O&M; Provider
<b>Code:</b>	British Standard 542: Earthing arrangements
<b>Status:</b>	Open

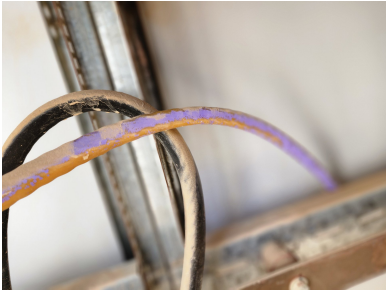
<b>Deficiency #2</b>	<b>RAC 2</b>	<b>Occurrences: 1</b>
----------------------	--------------	-----------------------

**Description:** Neutral earth link is undersized at 95mm<sup>2</sup>. Incoming supply is 300mm<sup>2</sup> single core conductors in parallel.

<b>Location:</b>	Within MDP.
<b>Category:</b>	Grounding and Bonding
<b>Equipment:</b>	MDP
<b>Imminent:</b>	No
<b>Action:</b>	N/A
<b>Assigned To:</b>	O&M; Provider
<b>Code:</b>	British Standard 542: Earthing arrangements
<b>Status:</b>	Open
