Task Force SAFE

Inspection-Report_TFSAFE_Full_KFAB22_Oiltown-Water-Point_116_04-06-26_1-7

Base Location	KFAB (Jordan)	Date:	04-JUN-2026
Base Code	KFAB22	Team #:	116
Building #	Oiltown-Water-Point	System Voltage	230/400
Building Type	OTHER	Inspection Phase	Full Inspection
Previous Report #:	N/A	Work Order:	TFS-KFAB22-2026-00004

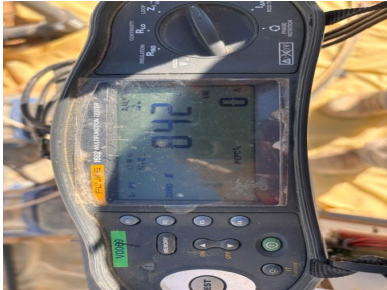
Deficiency #1	RAC 1	Occurrences: 1
----------------------	--------------	-----------------------

Description: High Zs reading of 842 ohms at the motor control station.

Location:	At motor control station.
Category:	Grounding and Bonding
Equipment:	PNL
Imminent:	Yes
Action:	Mitigated by notifying O&M; provider for repairs.
Assigned To:	O&M; Provider
Code:	British Standard 542: Earthing arrangements
Status:	Open

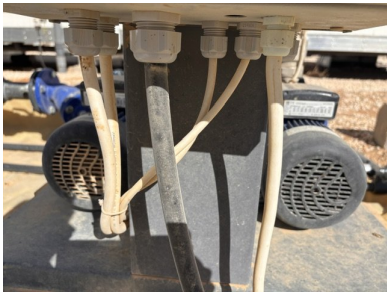
Deficiency #2	RAC 2	Occurrences: 1
----------------------	--------------	-----------------------

Description: SWA cable not bonded to earth.

Location:	At motor control station.
Category:	Grounding and Bonding
Equipment:	WLT
Imminent:	No
Action:	N/A
Assigned To:	O&M; Provider
Code:	British Standard 542: Earthing arrangements
Status:	Open

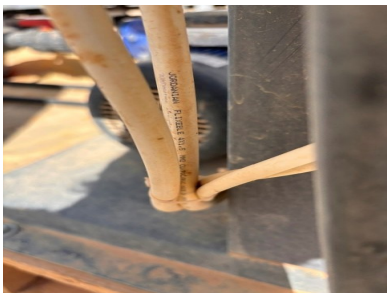
Deficiency #3	RAC 2	Occurrences: 5
----------------------	--------------	-----------------------

Description: Unlisted cables.

Location:	At motor control station.
Category:	Unlisted Equipment
Equipment:	WLT
Imminent:	No
Action:	N/A
Assigned To:	O&M; Provider
Code:	British Standard 511: Compliance with standards
Status:	Open

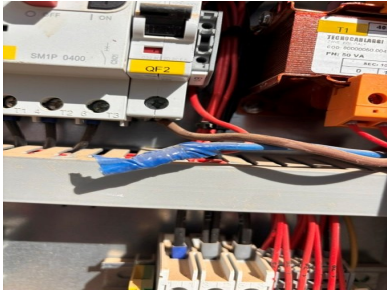
Deficiency #4	RAC 2	Occurrences: 1
----------------------	--------------	-----------------------

Description: Twist taped connections made.

Location:	At motor control station.
Category:	Improper Terminations
Equipment:	WLT
Imminent:	No
Action:	N/A
Assigned To:	O&M; Provider
Code:	British Standard 526: Electrical connections
Status:	Open

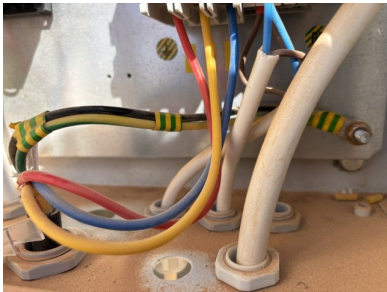
Deficiency #5	RAC 2	Occurrences: 1
----------------------	--------------	-----------------------

Description: Main earth and neutral terminated at same point.

Location:	Within the motor control station.
Category:	Grounding and Bonding
Equipment:	PNL
Imminent:	No
Action:	N/A
Assigned To:	O&M; Provider
Code:	British Standard 542: Earthing arrangements
Status:	Open

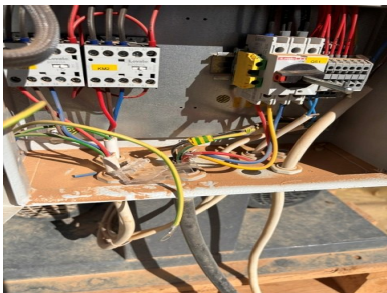
Deficiency #6	RAC 2	Occurrences: 2
----------------------	--------------	-----------------------

Description: Earth bond left unterminated.

Location:	Within the motor control station.
Category:	Improper Use / Damaged
Equipment:	PNL
Imminent:	No
Action:	N/A
Assigned To:	O&M; Provider
Code:	British Standard 542: Earthing arrangements
Status:	Open

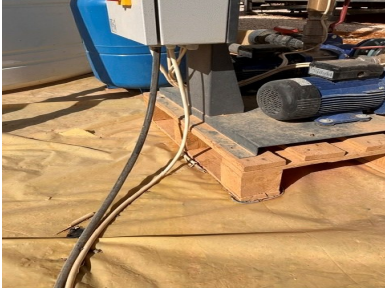
Deficiency #7

RAC 2

Description: No mechanical protection installed on cable.

Location:	Adjacent to motor control station.
Category:	Improper Use / Damaged
Equipment:	WLT
Imminent:	No
Action:	N/A
Assigned To:	O&M; Provider
Code:	British Standard 522: Selection and erection of wiring systems in relation to external influences
Status:	Open
