Task Force SAFE

Inspection-Report_TFSAFE_Full_5VN8M_1403_128_12-06-26_1

Base Location	JTC (Jordan)	Date:	12-JUN-2026
Base Code	5VN8M	Team #:	128
Building #	1403	System Voltage	230/400
Building Type	LSAU	Inspection Phase	Full Inspection
Previous Report #:	N/A	Work Order:	TFS-5VN8M-2026-00001

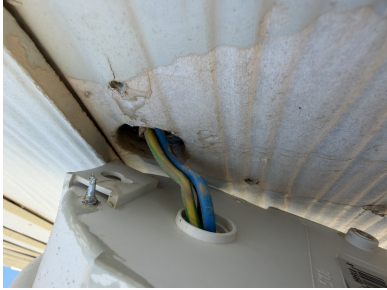
Deficiency #1	RAC 2	Occurrences: 1
----------------------	--------------	-----------------------

Description: No mechanical protection on single core cables passing through building structure.

Location:	Outside light fixture above Latrine door.
Category:	Improper Use / Damaged
Equipment:	WLT
Imminent:	No
Action:	N/A
Assigned To:	O&M; Provider
Code:	British Standard 522: Selection and erection of wiring systems in relation to external influences
Status:	Open
