## Task Force SAFE

## Inspection-Report\_TFSAFE\_Full\_ALQ26\_GEN-1-W\_113\_16-06-26\_0

<b>Base Location</b>	Al Quwayrah	<b>Date:</b>	16-JUN-2026
<b>Base Code</b>	ALQ26	<b>Team #:</b>	113
<b>Building #</b>	GEN-1-W	<b>System Voltage</b>	230/400
<b>Building Type</b>	GENERATOR	<b>Inspection Phase</b>	Full Inspection
<b>Previous Report #:</b>	N/A	<b>Work Order:</b>	TFS-ALQ26-2026-00013

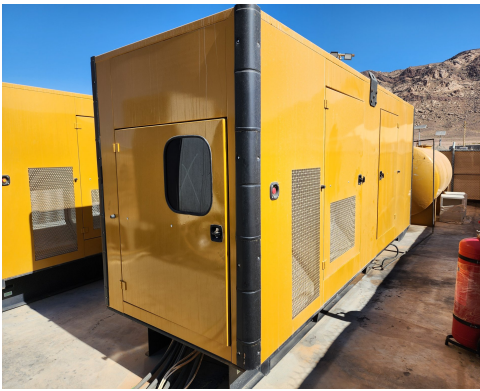
**Building Picture:**

**Overall Building Electrical System:** Fair

GEN-1 of 3. Generator serial number - LWL11010. Generator is on standby, not running at this time. All cabling, terminations and earthing arrangements. Neutral/earth link is located at the MDP. No LHS deficiencies found. GEN-1 ground electrode conductor is 300mm<sup>2</sup> and is run from the MET within GEN-1 via the MET within the ATS, then terminating to two ground rods spaced 9ft apart.
