Task Force SAFE

Inspection-Report_TFSAFE_Full_7NX32_Hangar-RM-1_128_16-06-26_1-3

Base Location	H-5 (Jordan)	Date:	16-JUN-2026
Base Code	7NX32	Team #:	128
Building #	Hangar-RM-1	System Voltage	230/400
Building Type	HANGAR	Inspection Phase	Full Inspection
Previous Report #:	N/A	Work Order:	TFS-7NX32-2026-00001

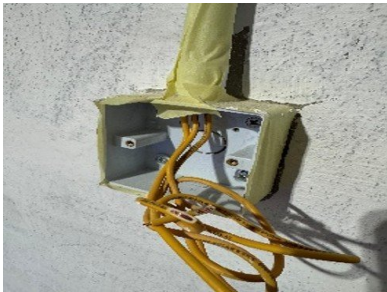
Deficiency #2	RAC 2	Occurrences: 1
----------------------	--------------	-----------------------

Description: No CPC at light switch.

Location:	Light switch is located in the right hand office inside Rm-1.
Category:	Grounding and Bonding
Equipment:	WLT
Imminent:	No
Action:	N/A
Assigned To:	O&M; Provider
Code:	British Standard 542: Earthing arrangements
Status:	Closed / Repaired

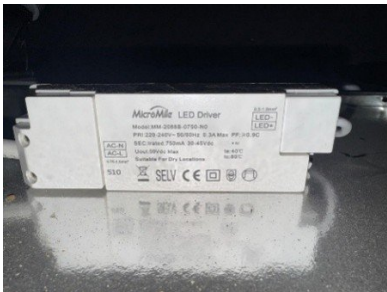
Deficiency #3	RAC 2	Occurrences: 24
----------------------	--------------	------------------------

Description: LED drivers are unlisted. Data sheet required.

Location:	LED drivers at light fixtures.
Category:	Unlisted Equipment
Equipment:	WLT
Imminent:	No
Action:	N/A
Assigned To:	O&M; Provider
Code:	British Standard 511: Compliance with standards
Status:	Open
